The effects of multipath propagation on the range measurement system at Fort Hunter Liggett

THE EFFECTS OF MULTIPATH PROPAGATION
ON THE RANGE MEASUREMENT SYSTEM
AT FORT HUNTER LIGGETT

December 1977

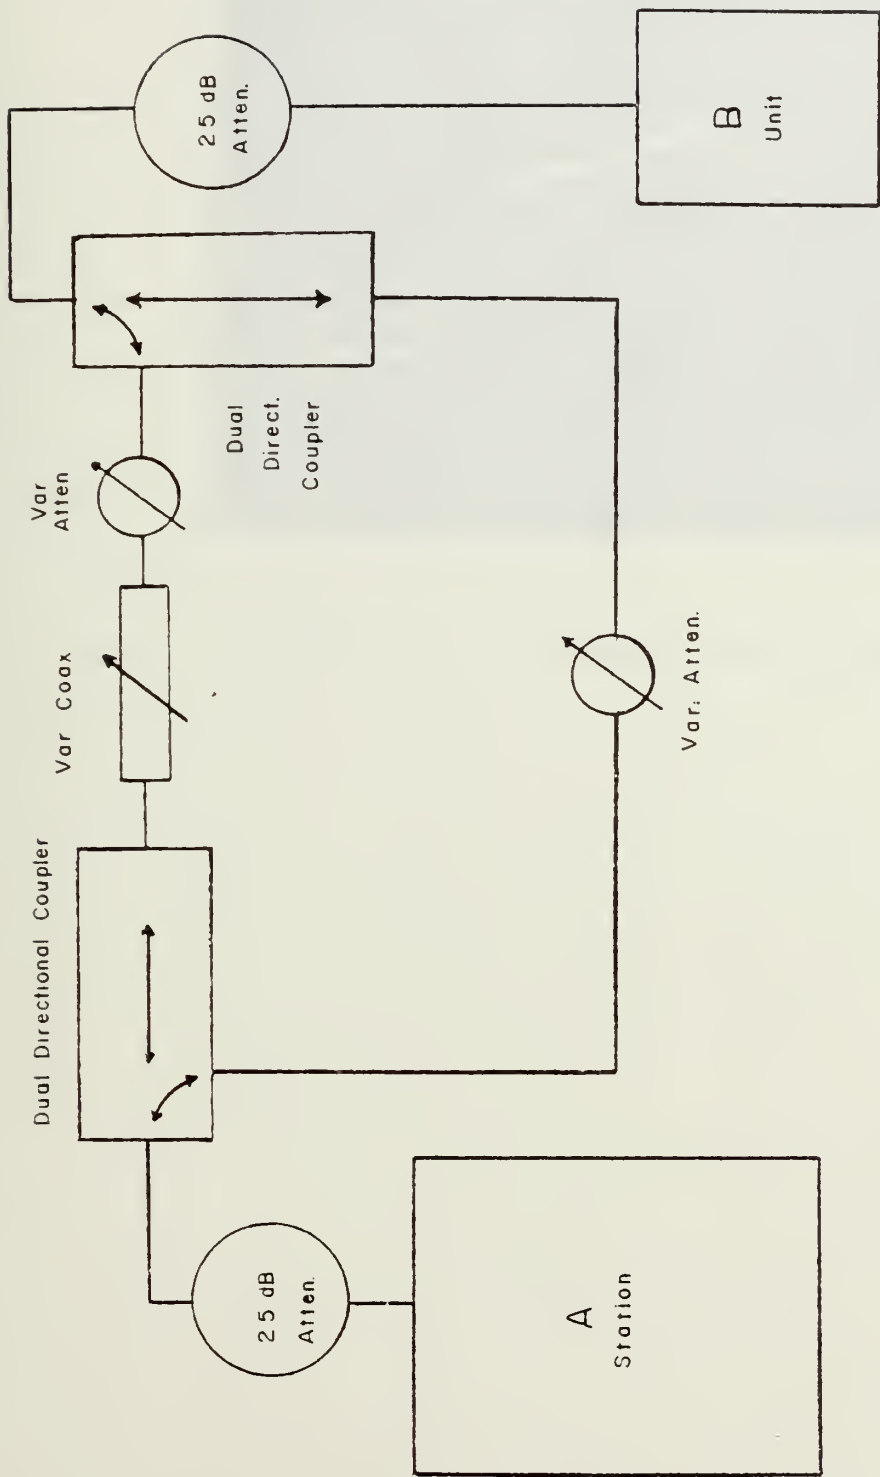
Figure 14 - MULTIPATH SIMULATION SETUP

The experiments conducted with this setup demonstrated that it was possible to distort the signals arriving at the A station and B unit enough to cause significant errors in the system. Figure 15 is an example of a distorted range pulse that led to a 'no B response' result though the system was working well within its specified operating range. The procedures and data collected for the multipath experiments is presented in Appendix D. The only system failure that occurred during these tests was a reoccurrence of the problem in the B unit checkout set. An external 5 VDC source was hooked up to the logic unit and this remedied the problem.

The basic multipath simulation of Figure 14 was used in several experiments to test the system response to two signals arriving at the A station or the B unit at about the same time. The overall objective of these experiments was to determine if it was possible to create conditions that might cause system errors such as 'wild' ranges. Dual directional couplers were used to isolate the two signals so different combinations of signal strength and path lengths could be investigated. A section of variable length coaxial cable inserted in the direct path allowed for the changing of the phase relation between the two signals as they combined at either the A station or the B unit. Figure 48 is the actual laboratory simulation setup with the RF shielding material removed.

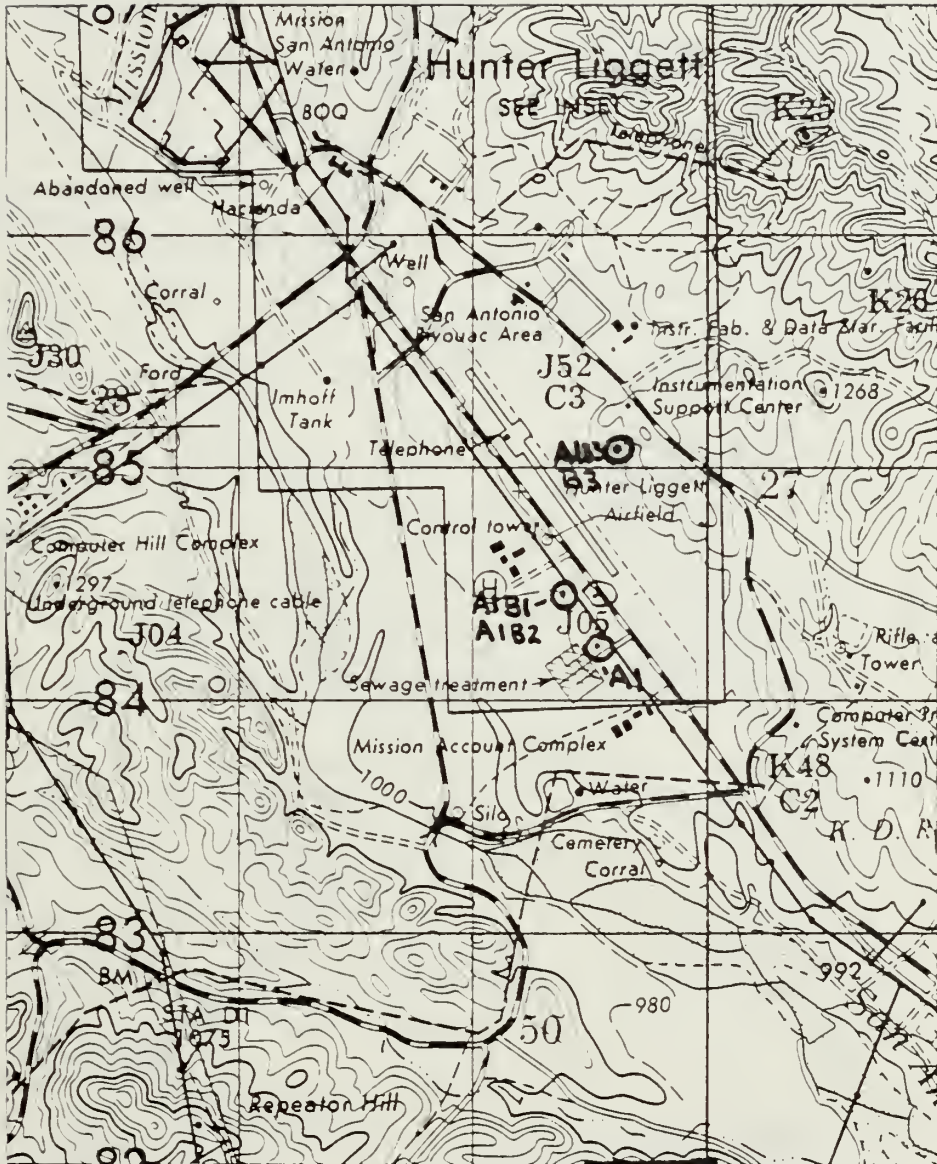
Figure 24 - FT HUNTER LIGGETT OPERATING AREA

Extensive logistic support and coordination was required during all phases of the field experiments. The areas of Ft. Hunter Liggett that were used for most of the preliminary reliability investigations are shown in Figures 23 and 24. The tests conducted in these areas were limited to the weekends due to USACDEC experimentation schedules. Thus, any RMS component failure usually forced a delay in the testing to the next weekend. Later in the testing a mobile A station antenna was made available at Camp Roberts (Figure 25) where the terrain is very similar to that at Ft. Hunter Liggett. Testing at Camp Roberts was not restricted to any time period and allowed for easier support.

A station site E20 was chosen for the subsequent field tests. Its location and those for the B units are shown in Figure 24. Although for A2B1 and A2B2 the distances from the A station to the B unit were well within the system coverage not a single E unit response could be obtained for both units. At this time it was not clearly understood why the RF link was working so badly. Therefore the objective of the test was changed into a continuing hardware reliability investigation. Since broken E unit antenna elements as well as bad cables and connectors could have caused a RF link failure those components were interchanged frequently without any improvement. Parallel to this the A station power output and signal waveform were checked and compared with the specifications. No malfunctions of the A station could be detected.

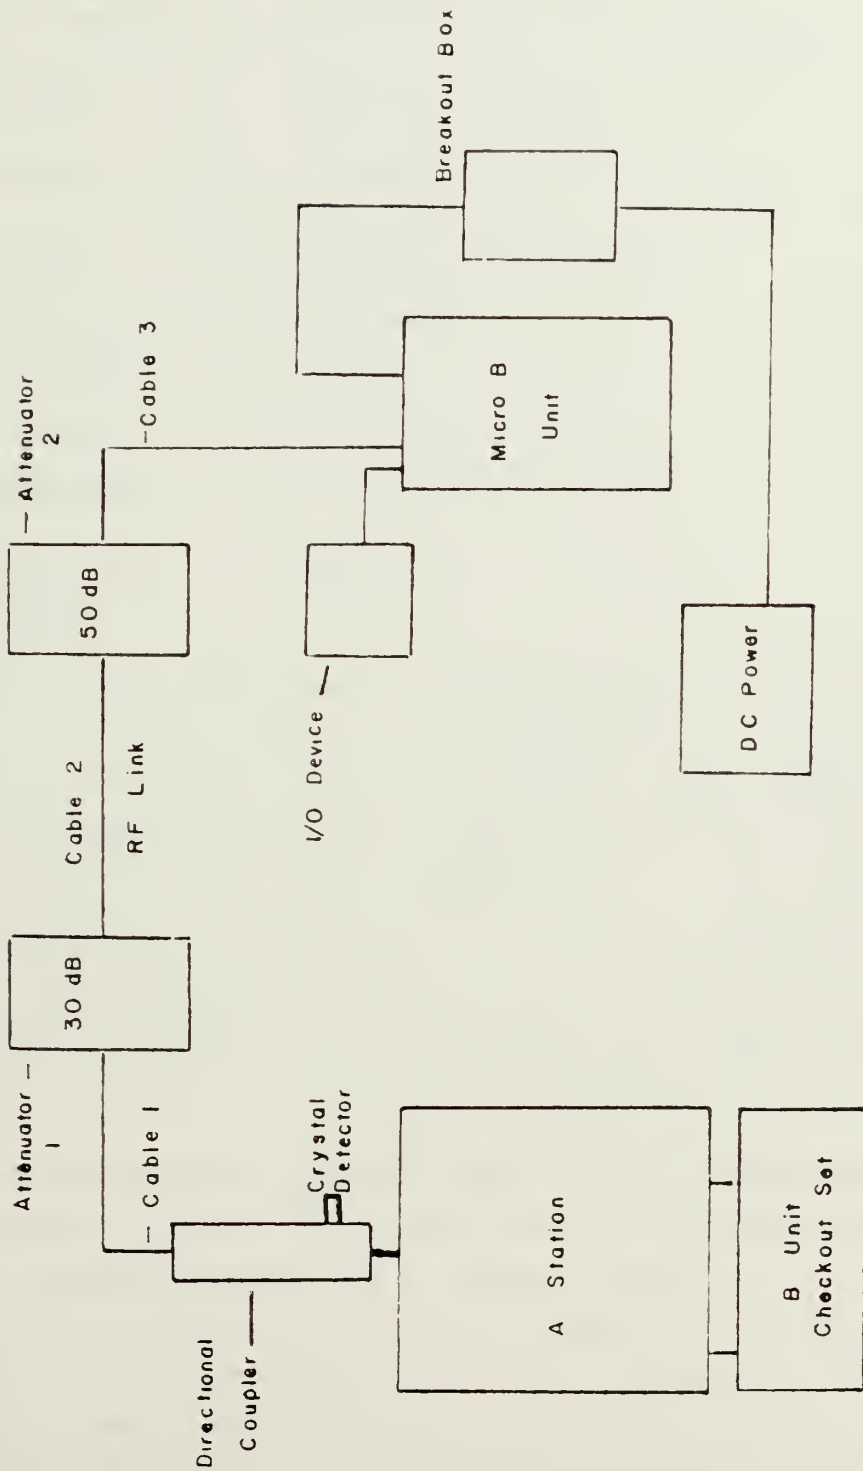
Figure 31 - EXPERIMENT 1 SETUP

1. A station 010, micro-B unit 237 and the B unit checkout set were set up as shown in Figure 31. The nomenclature and serial numbers of the other experiment hardware is given.

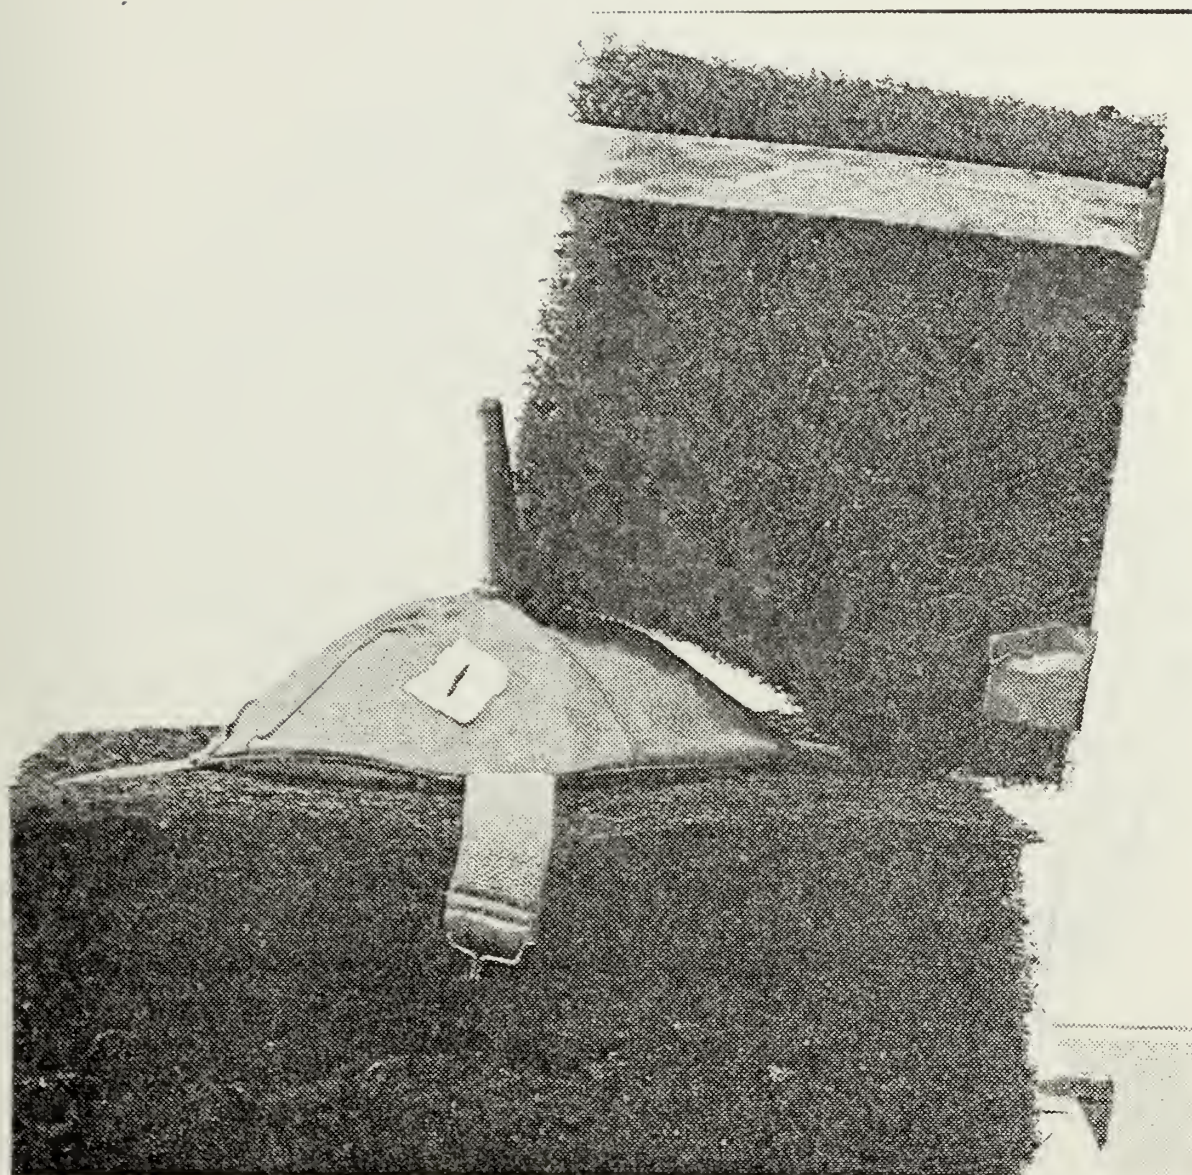
Figure 76 - FIELD CONFIGURATION B

Configuration B is shown in Figure 76 and consists of a one and one-half inches wide strip of aluminum vertically oriented placed in front of the antenna of configuration C. The space between the antenna and the metal was filled with absorbing material. The horizontal pattern for configuration B is shown in Figure 77. The desired maximum gain in the sideward directions was about 1 dB below that of the omnidirectional antenna. The gain reduction achieved in the forward direction was almost 6 dB relative to the sideward level.
