## Mark XIV Torpedo Case Study

**MARK XIV TORPEDO CASE STUDY**

David F. Matthews, Senior Lecturer

February 2011

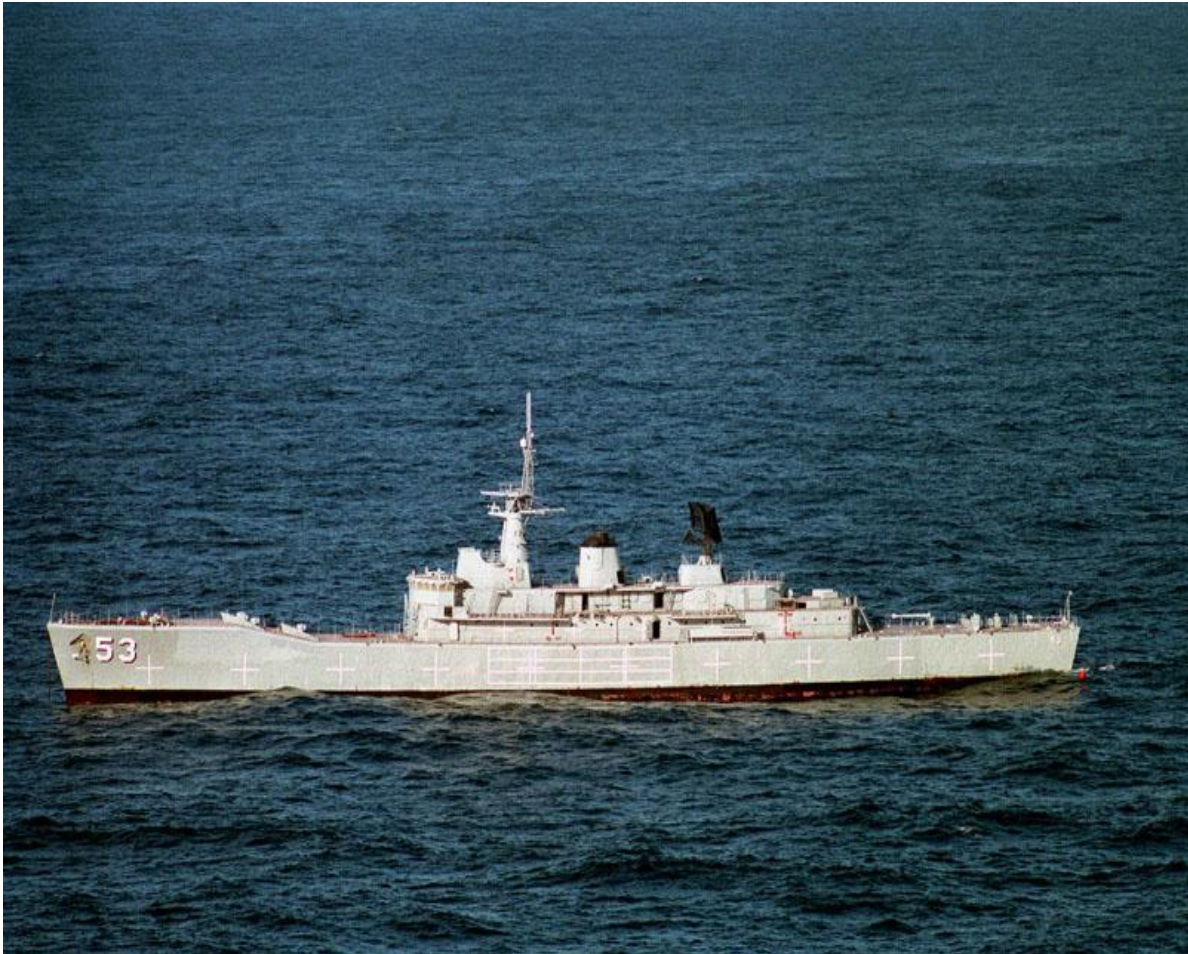
**Figure 2. Destroyer Prior to Detonation**  
(Navy Undersea Warfare Center, 1999)

Figure 2 is a picture of the obsolete full-sized Australian destroyer that served as the test target. Everything useful was removed from the destroyer—all turrets, depth charges, secondary armament, etc. The configuration is visible in subsequent

photos. Figure 2 shows the target ship sitting dead in the water waiting to be engaged.

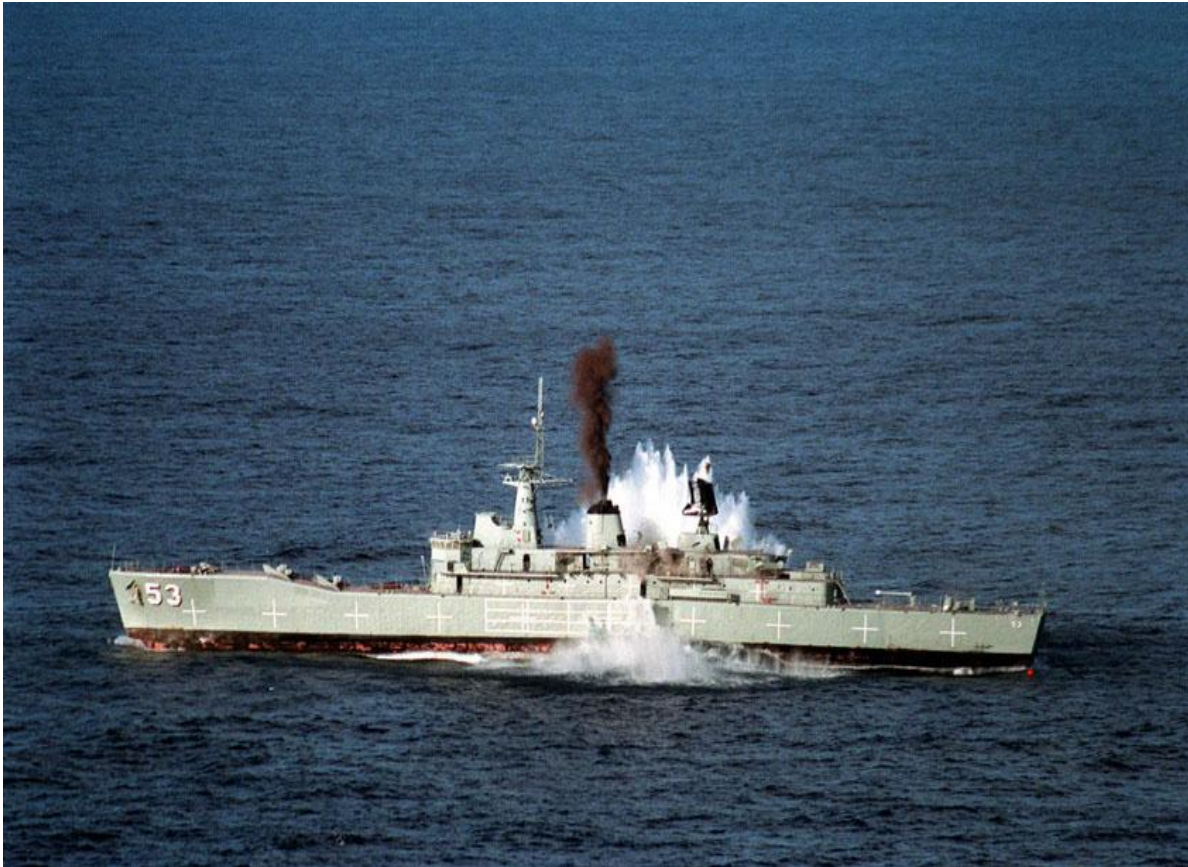
**Figure 3. Initial Reaction**  
(Navy Undersea Warfare Center, 1999)

Figure 3 is a photograph of the moment the torpedo was detonated. The photograph shows that smoke has been blown out of the stack because of the power of the explosion, and it shows that water is starting to erupt on either side of the ship. In Figure 3, the ship already appears to have had its keel broken because the bow and the stern are lower than the center of the ship.

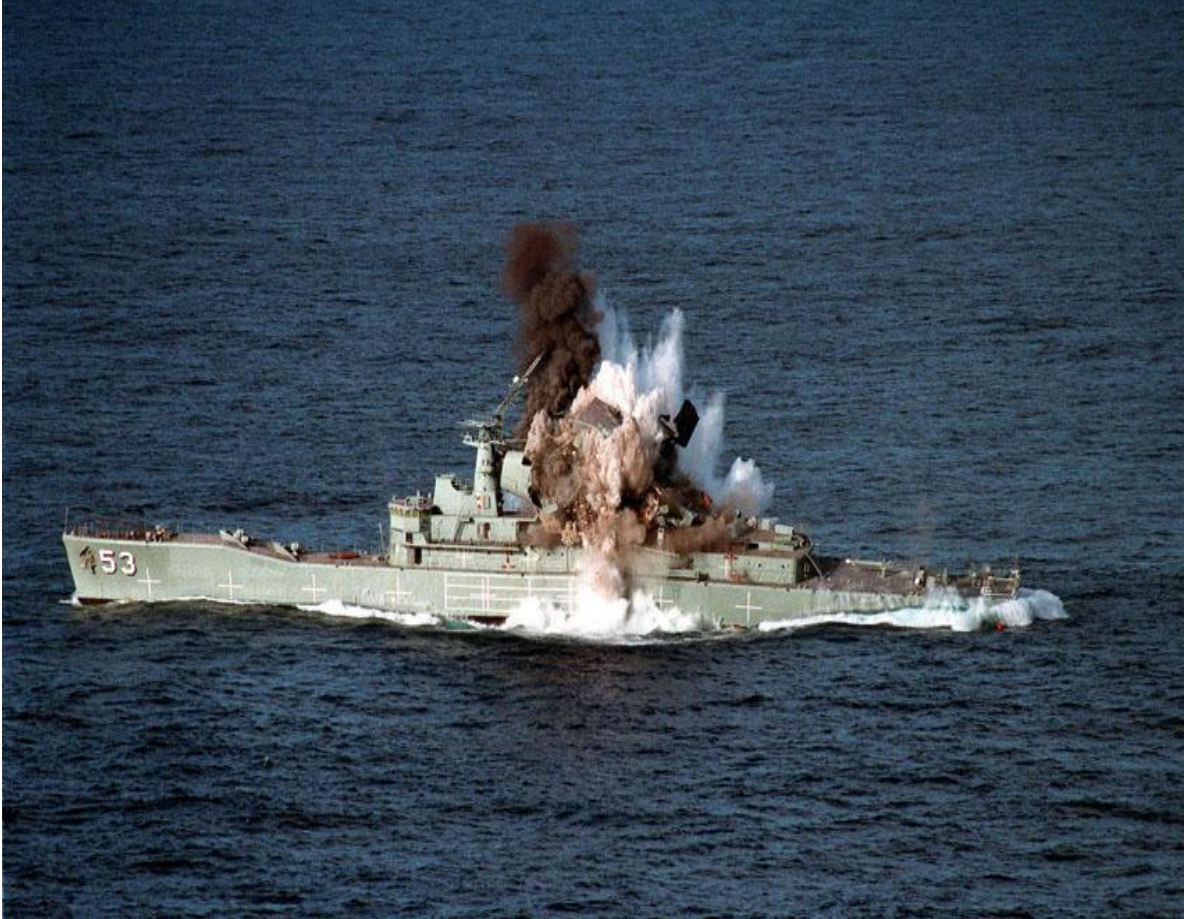
**Figure 4. Further Damage**  
(Navy Undersea Warfare Center, 1999)

Figure 4 is a photograph of a few seconds, maybe even milliseconds, later. The explosion has propagated even further, and the power of the torpedo warhead's explosive is visible as it goes straight up through the bowels of the ship along the center line—and it only gets worse.

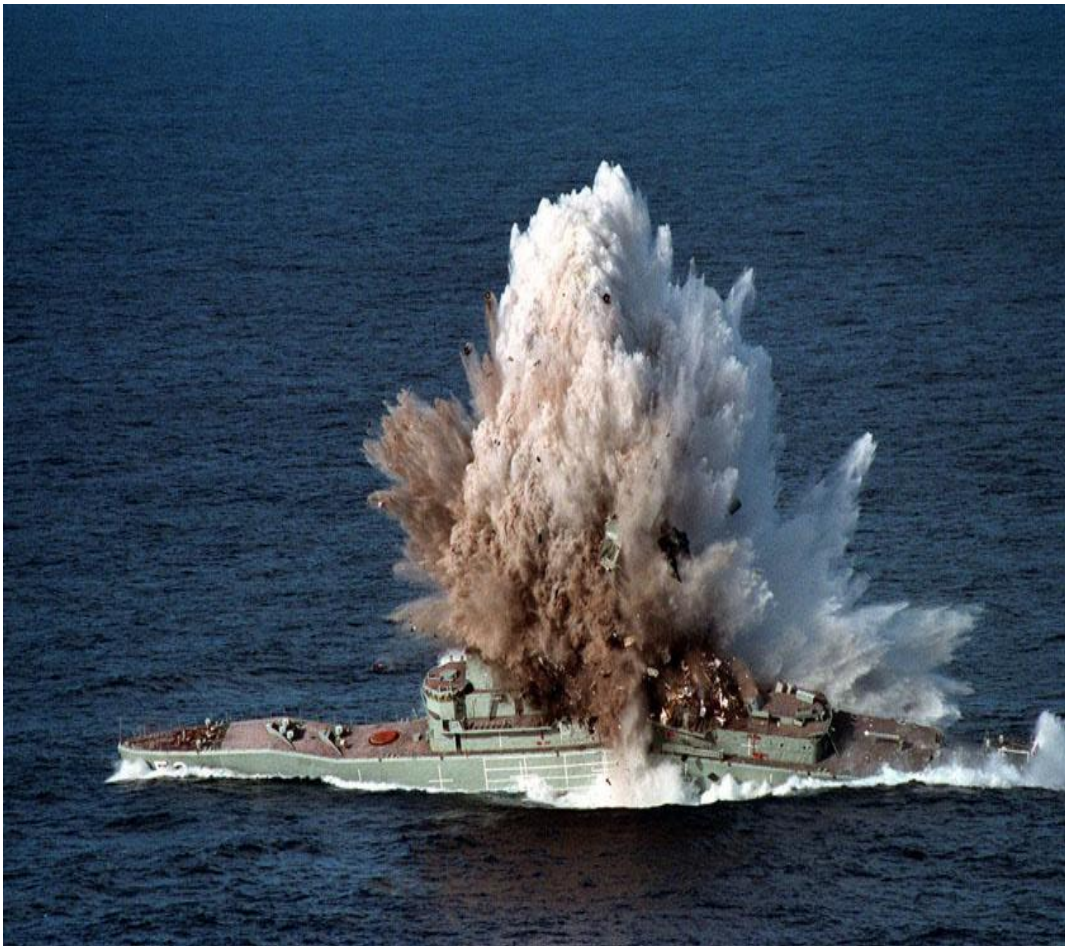
**Figure 5. The Keel Has Broken**  
(Navy Undersea Warfare Center, 1999)

Figure 5 clearly shows that the back of the destroyer has been broken. The extensive level of damage that is taking place is obvious.

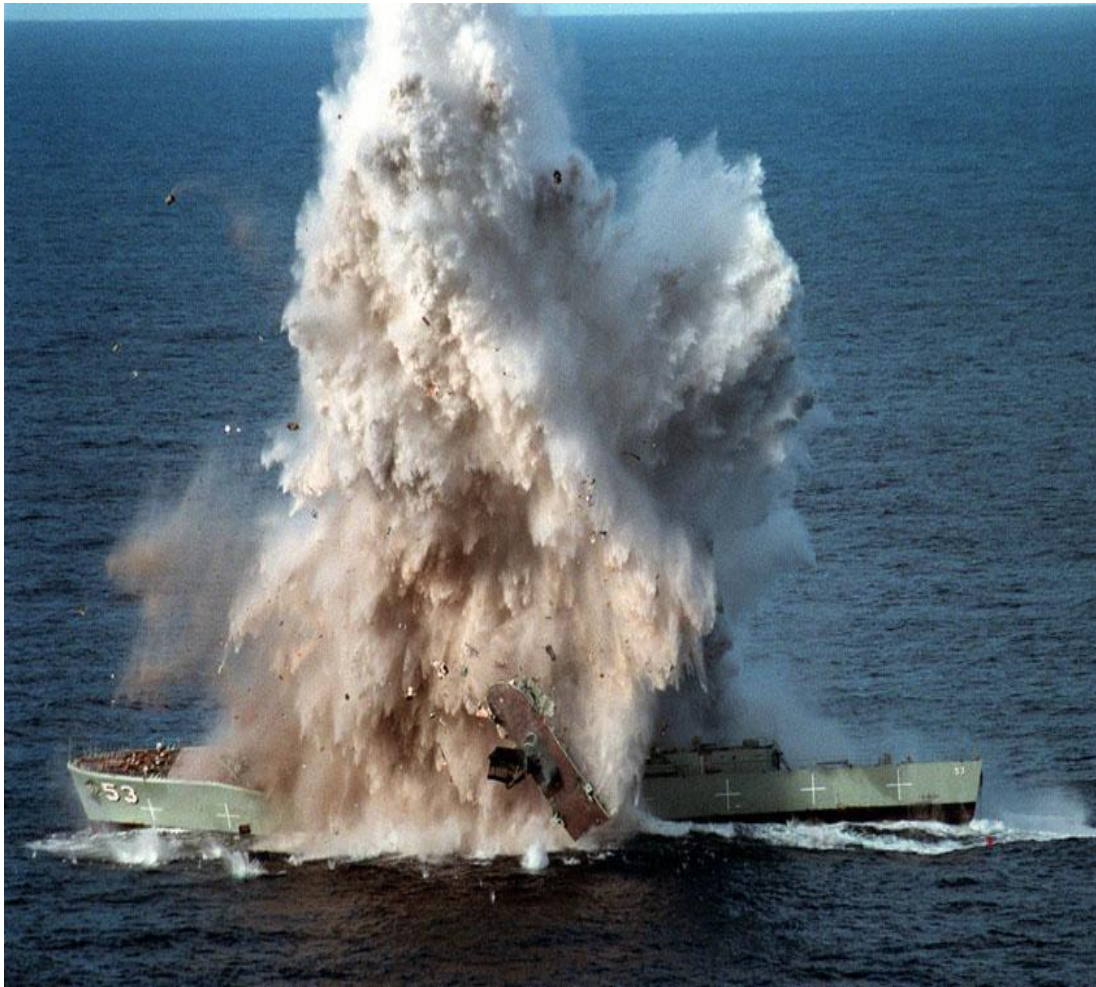
**Figure 6. Bow and Stern Sections Separate**  
(Navy Undersea Warfare Center, 1999)

Figure 6 shows that the level of damage is now catastrophic.

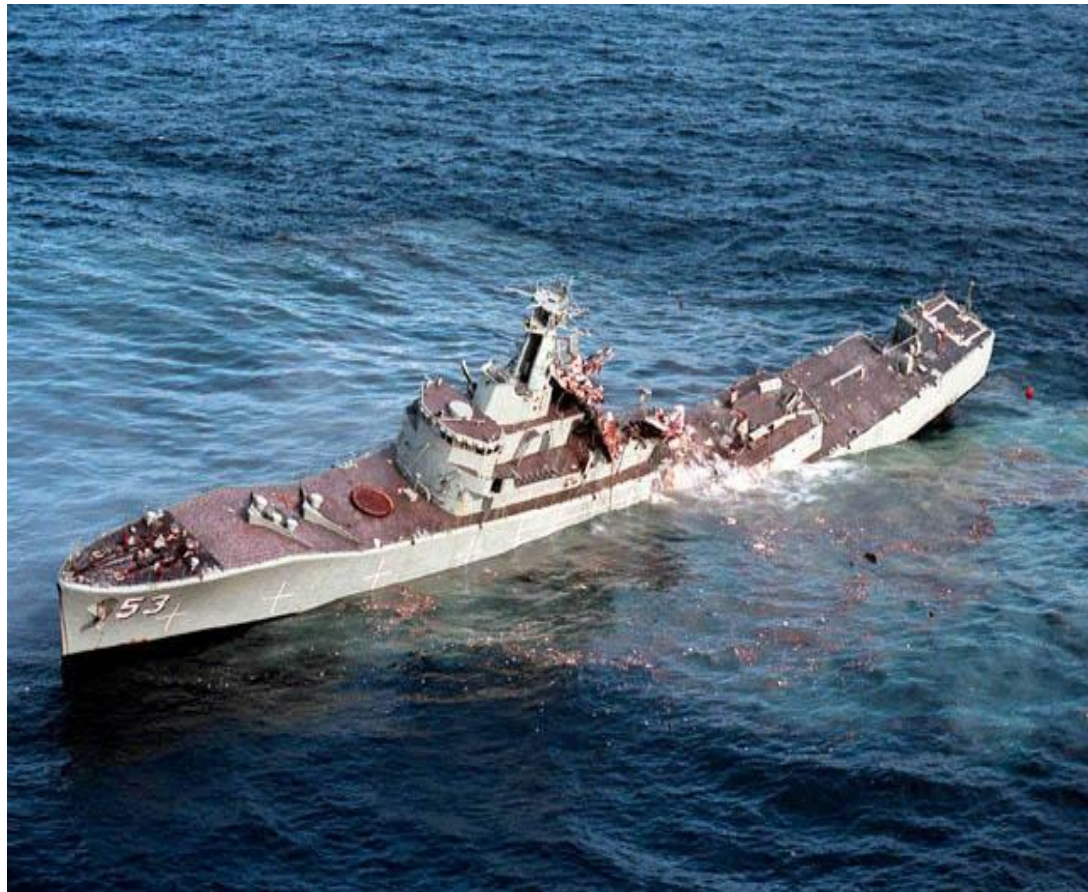
**Figure 7. The Stern Begins to Sink**  
(Navy Undersea Warfare Center, 1999)

As the smoke clears in the photograph in Figure 7, it is clear that the destroyer has broken into two halves and that the stern section is about to sink.

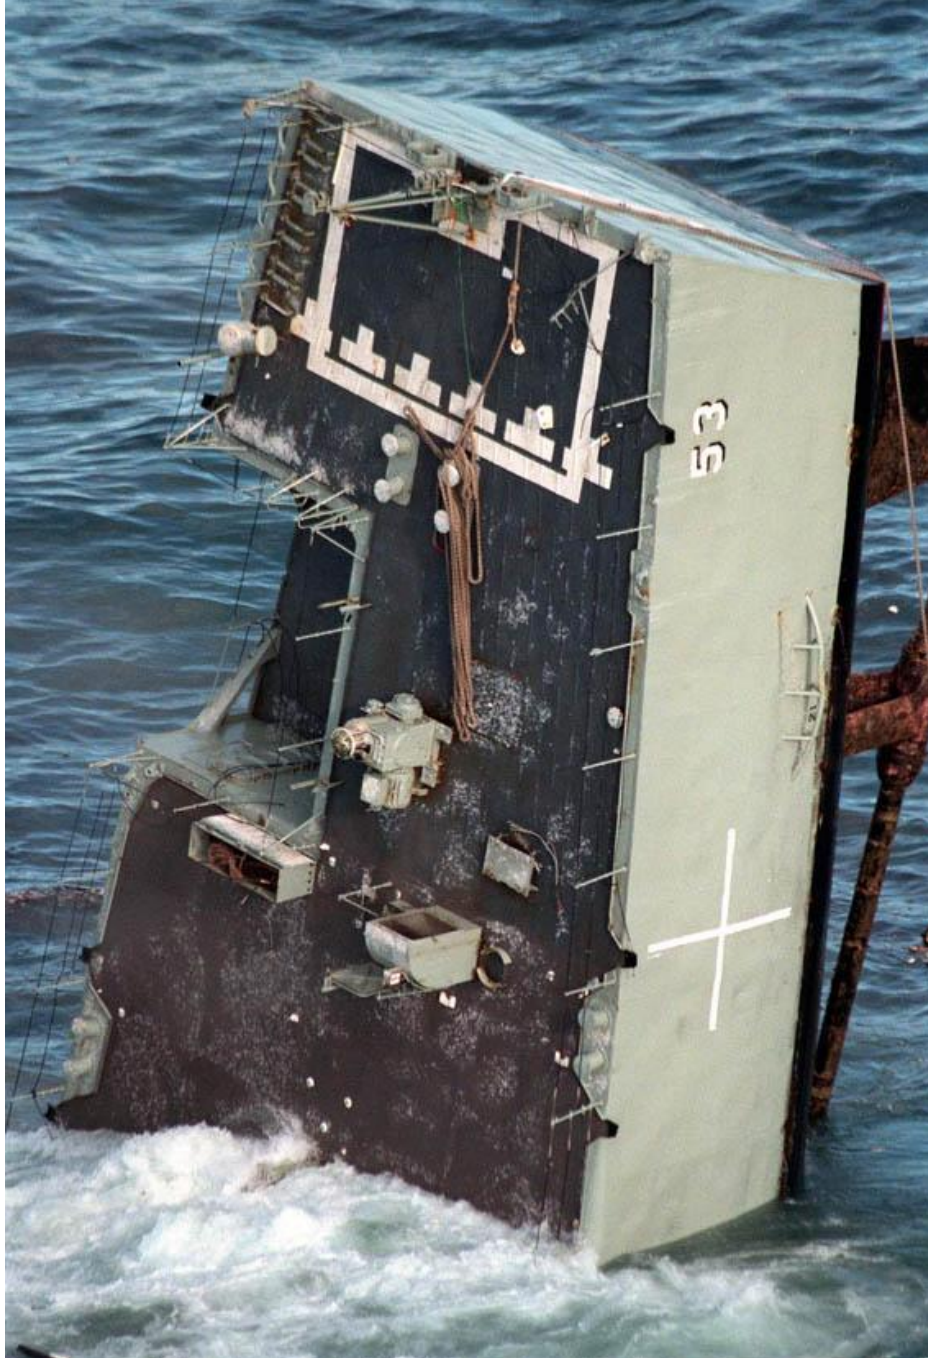
**Figure 8. The Stern Slips Under the Waves**  
(Navy Undersea Warfare Center, 1999)

Figure 8 shows that the observation made in Figure 7 is accurate: the stern section is headed to “Davey Jones’ Locker.” The photograph in Figure 8 is a close-up of the destroyer as it slips beneath the waves.

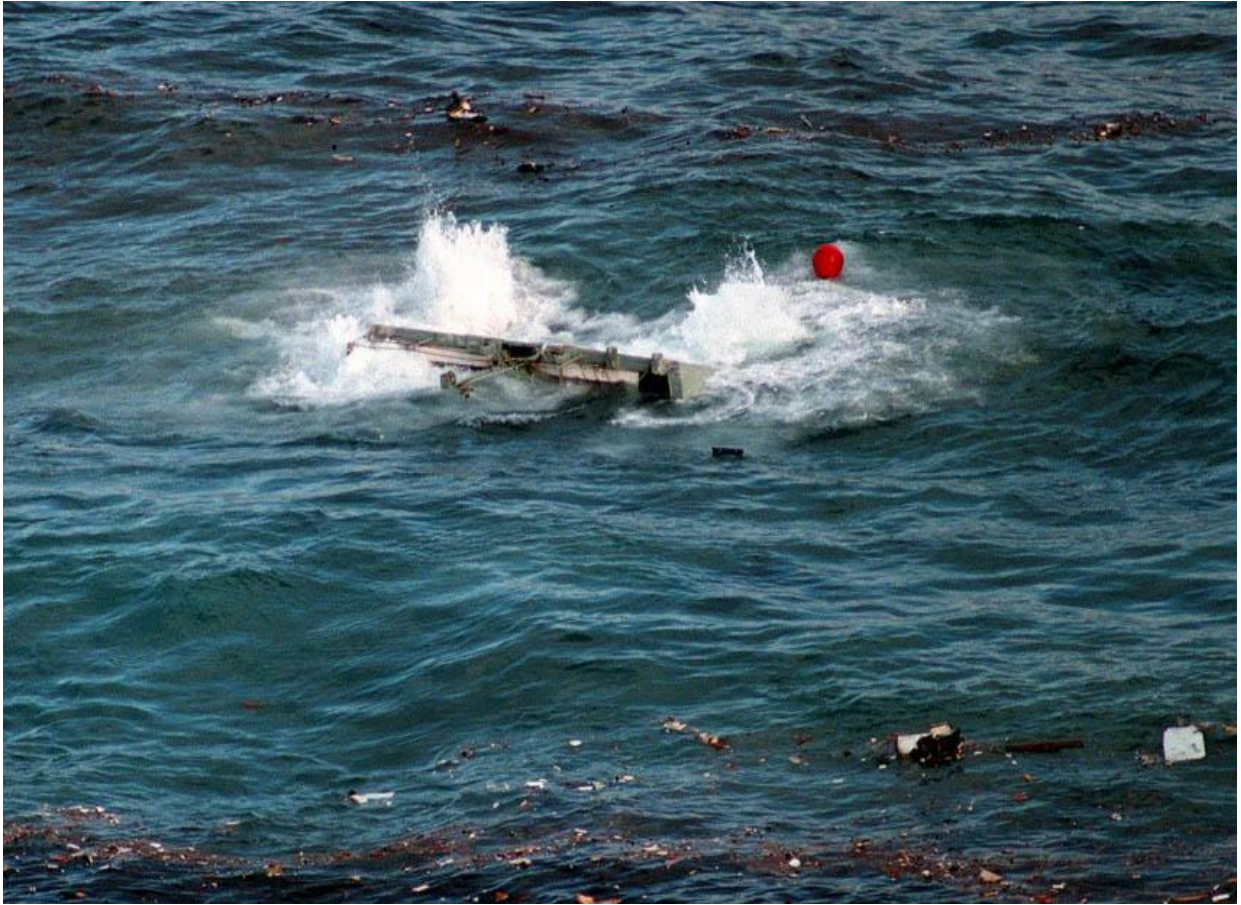
**Figure 9. The Stern Disappears**  
(Navy Undersea Warfare Center, 1999)

Figure 9 is a close-up photograph of the residual debris field.

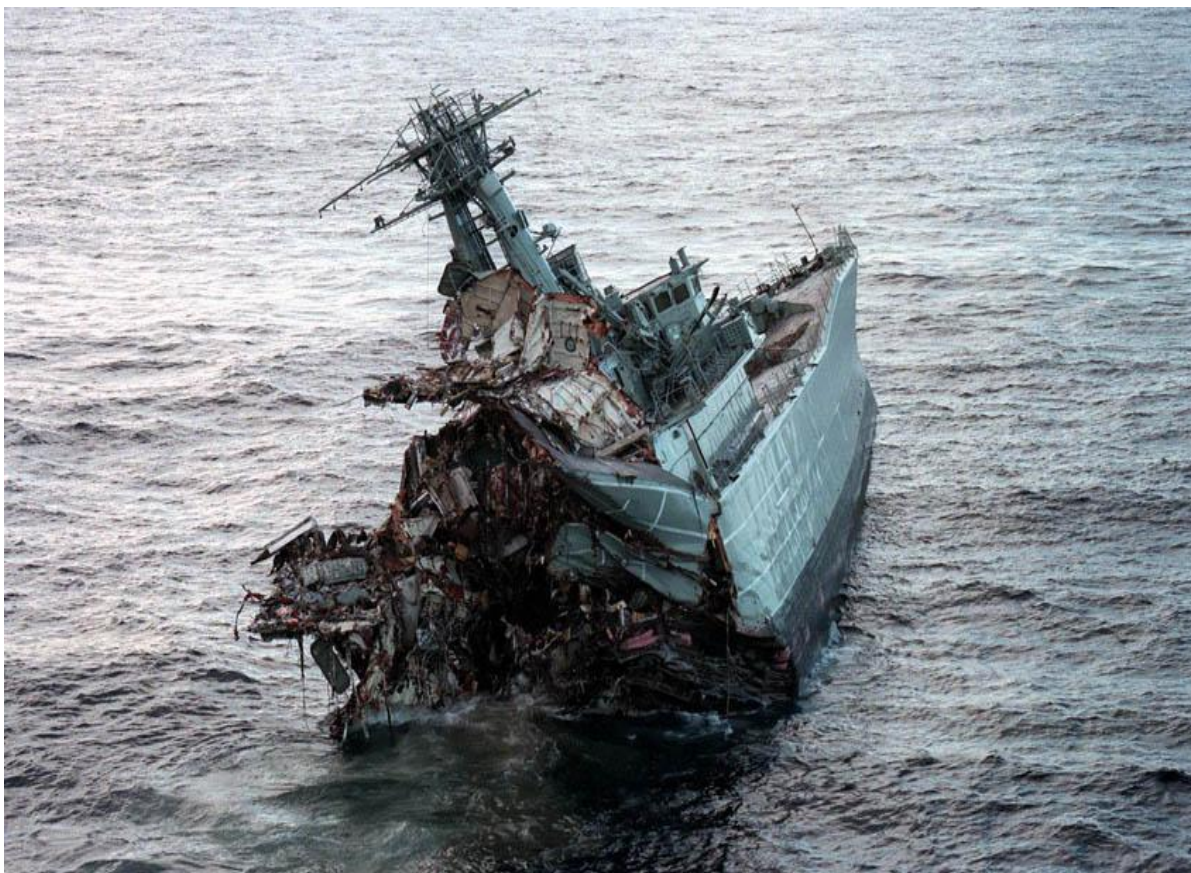
**Figure 10. The Residual Bow Section**  
(Navy Undersea Warfare Center, 1999)

Figure 10 is a photograph of the bow section of the ship. As the photograph shows, it is not economically repairable. The damage is so bad that by the time the Australian Navy would have tried to salvage what is left there in order to rebuild a new ship around it, it would have been better to have started from scratch. Plus, ship designs evolve, and if this were an older ship, it would probably be better from a cost-effectiveness standpoint to acquire a “latest and greatest” warship of a similar class to replace this one. In this test, the bow section actually sank a few hours after the photograph in Figure 10 was taken.
