A Suitable Platform for Storm Penetration, Risk Analysis for the SPA-10 Aircraft Modification

2016-01-2043

Richard C. Millar and Thomas Mazzuchi

The SPA-10 project, sponsored by U.S. National Science Foundation, is to acquire and qualify a replacement for the retired T-28 "storm penetration" aircraft previously used to acquire meteorological data to enable understanding and modelling of mid-continent thunderstorms. The National Science Foundation selected the Fairchild A-10 (bailed from the U.S. Air Force) as the platform to be adapted to perform the storm penetration mission to altitudes of eleven kilometers, and funded Naval Postgraduate School's Center for Interdisciplinary Remotely-Piloted Aircraft Studies (CIRPAS) as prime contractor. An expert panel conducted a review of the SPA-10 project in 2014 and recommended a risk analysis addressing hazards to the aircraft and pilots, such as icing, hail, turbulence and lightning. This paper presents the results of the risk analysis performed in response to this need, including recommended mitigations.

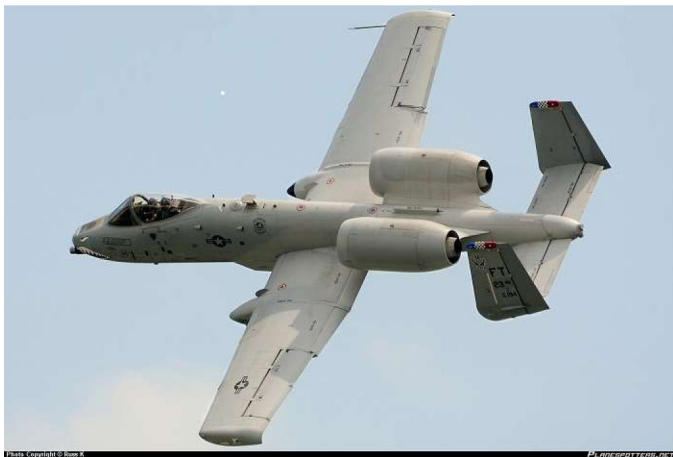
Figure 1. Fairchild A-10 Thunderbolt, a.k.a “Warthog” Note the positioning of the engine inlets relative to the inner wing section. https://img.planespotters.net/photo/302000/original/80-0194-usaf-united-states-air-force-fairchild-a-10c-thunderbolt-ii_PlanespottersNet_302341.jpg.
