# Laser peening for mitigation of stress corrosion cracking at welds in marine aluminum

**LASER PEENING FOR MITIGATION OF STRESS  
CORROSION CRACKING AT WELDS IN MARINE  
ALUMINUM**

Heather R. Mattern

June 2011

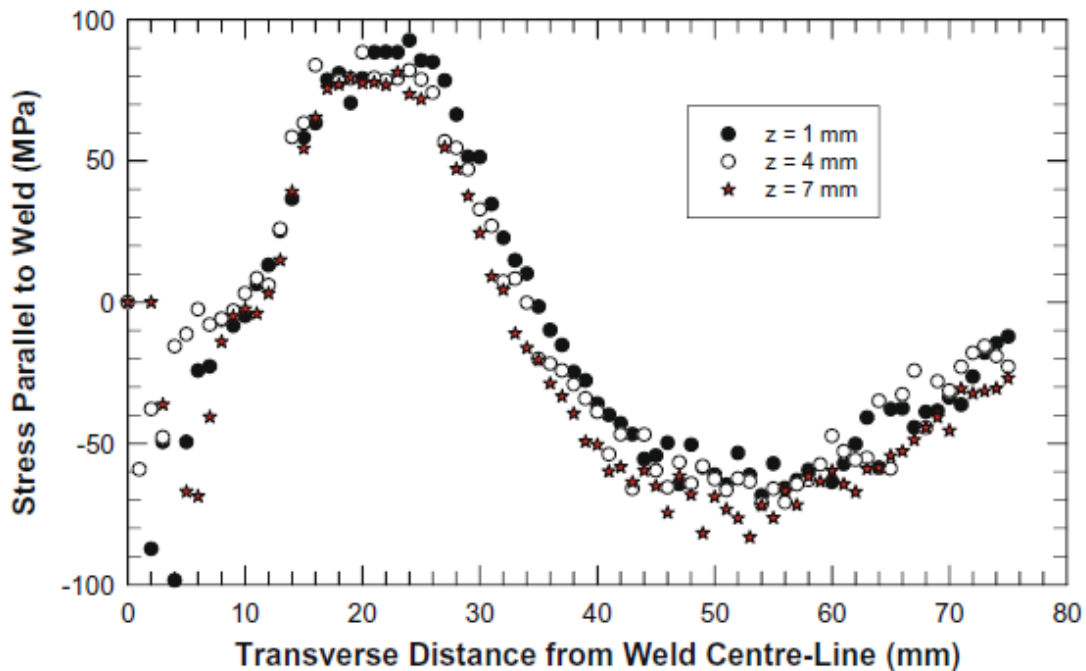
Figure 4. Comparison between longitudinal stresses in AA5083-H321 MIG weld (From [7]).

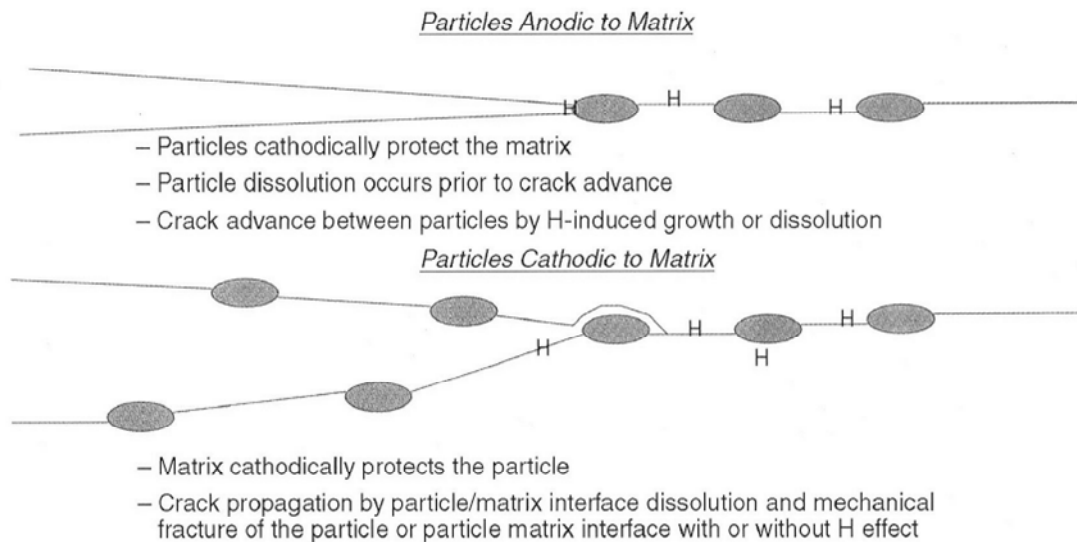
Figure 8. Schematic showing possible crack-tip/particle interactions for electrochemically active particles (From [9]).

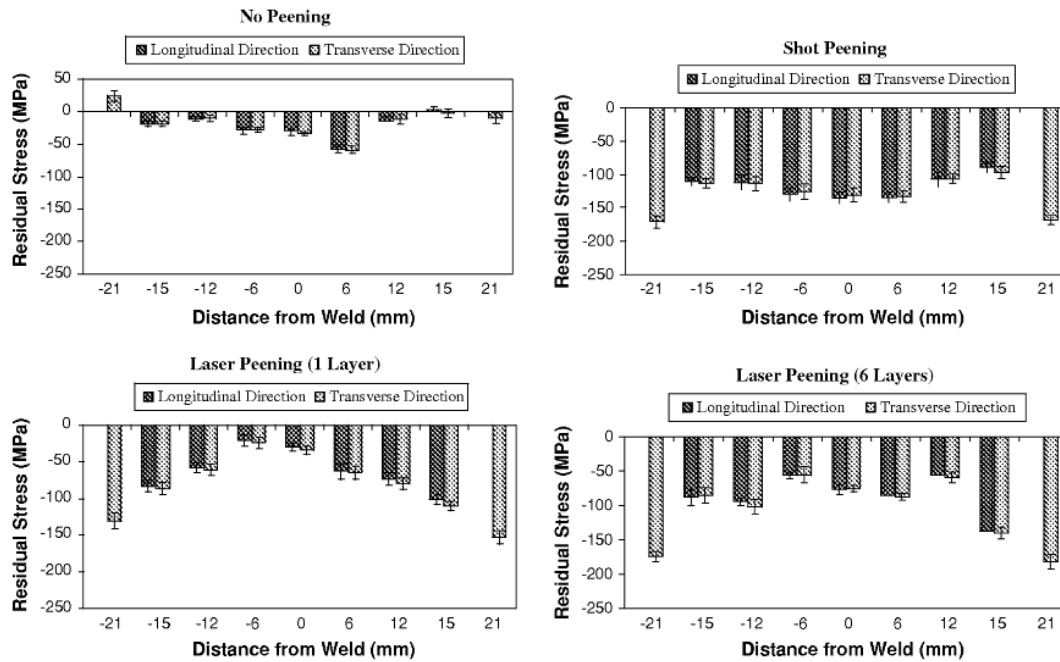
Figure 13. Residual stress for different peening conditions (From [13]).

Hatamleh studied the SCC behavior of both shot and laser peened friction stir welded 2195 aluminum alloy joints [17]. The peening effects using a slow strain rate test in 3.5% NaCl solution and the laser peened samples demonstrated superior properties to the other samples (Table 1). The residual stresses were also analyzed as shown in Figure 13.

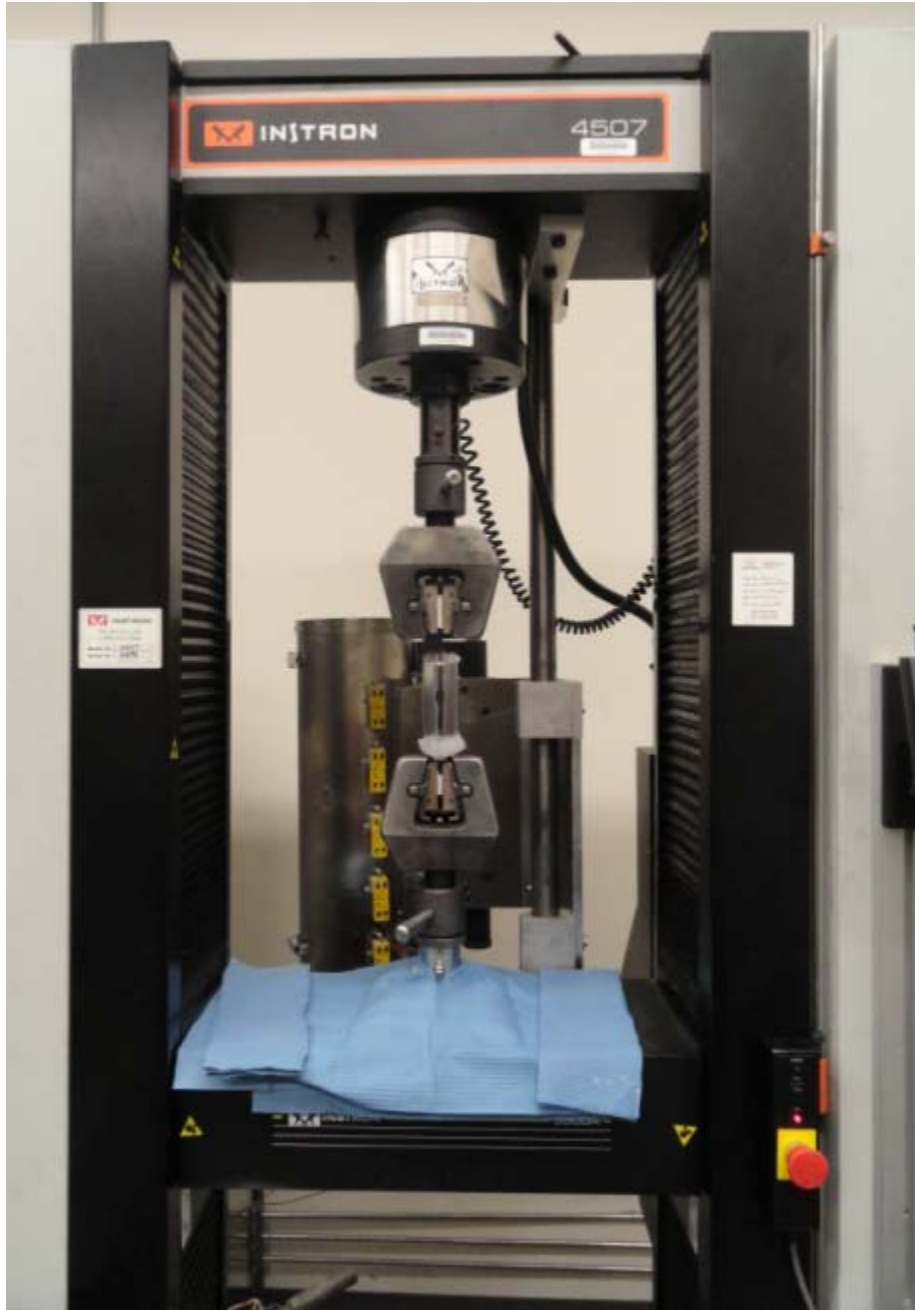
Figure 17. Instron 4507 test frame used in the SSRT testing of laser peened samples.

The SSRT was carried out on an Instron 4507 test frame (Figures 17 and 18). This instrument used an Instron load cell with a load rating of 200 kN static and 100 kN dynamic in both compression and tension, for force measurement and screw-driven, cross-head displacement for strain measurement. The 4507 frame has a testing speed range of 0.001 to 500 mm/min. All stresses and strains were computed as engineering stresses and strains using the original and final dimensions of the specimen. As these tests were concerned primarily with strain to failure, these measurements of stress and strain were deemed sufficient. All tests were performed with a constant extension rate of 50 nm/second. This displacement rate was chosen based upon a desired uniaxial strain rate of  $10^{-6}$  for the geometry of specimen shown in Figure 15. This strain rate is consistent with the work done by Zucchi and Hatamleh [5, 13]. It is also within the parameters set forth in ASTM G 129-00, Standard Practice for Slow Strain Rate Testing to Evaluate the Susceptibility of Metallic Materials to Environmentally Assisted Cracking [19]. It should be noted that this displacement rate only gives a strain rate of  $10^{-6}$  at the start of the test. The strain rate decreases as the specimen becomes longer.

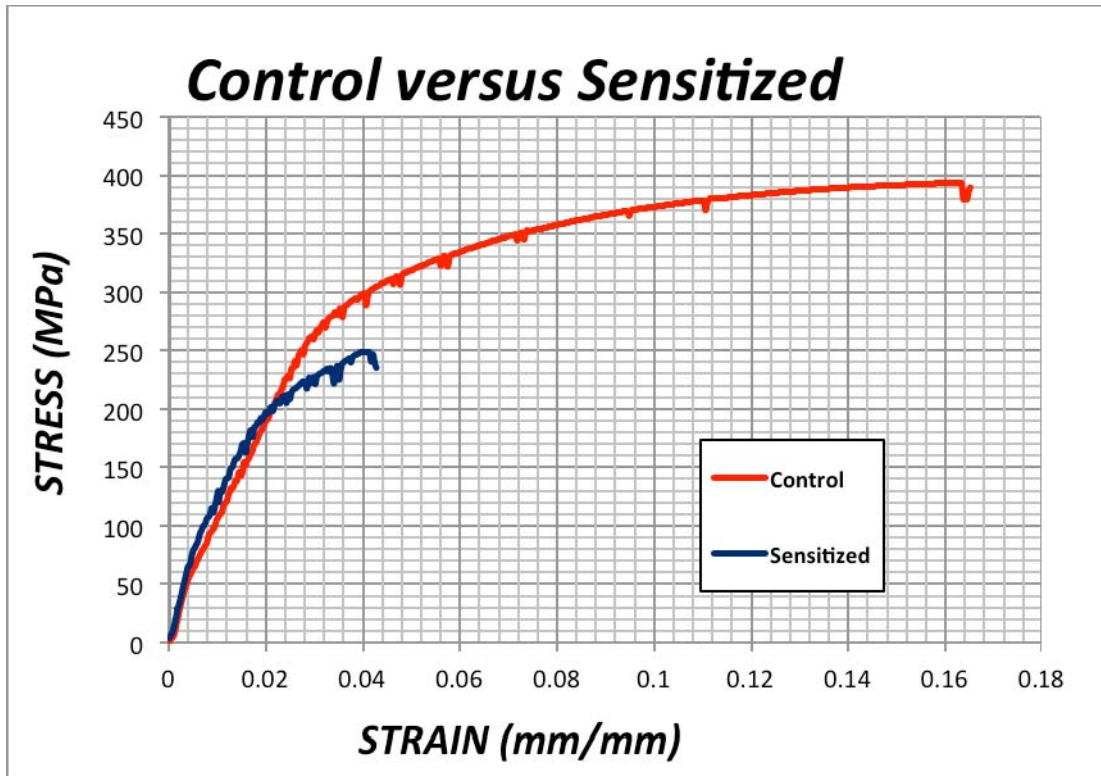
Figure 21. Control versus Sensitized stress strain curve.

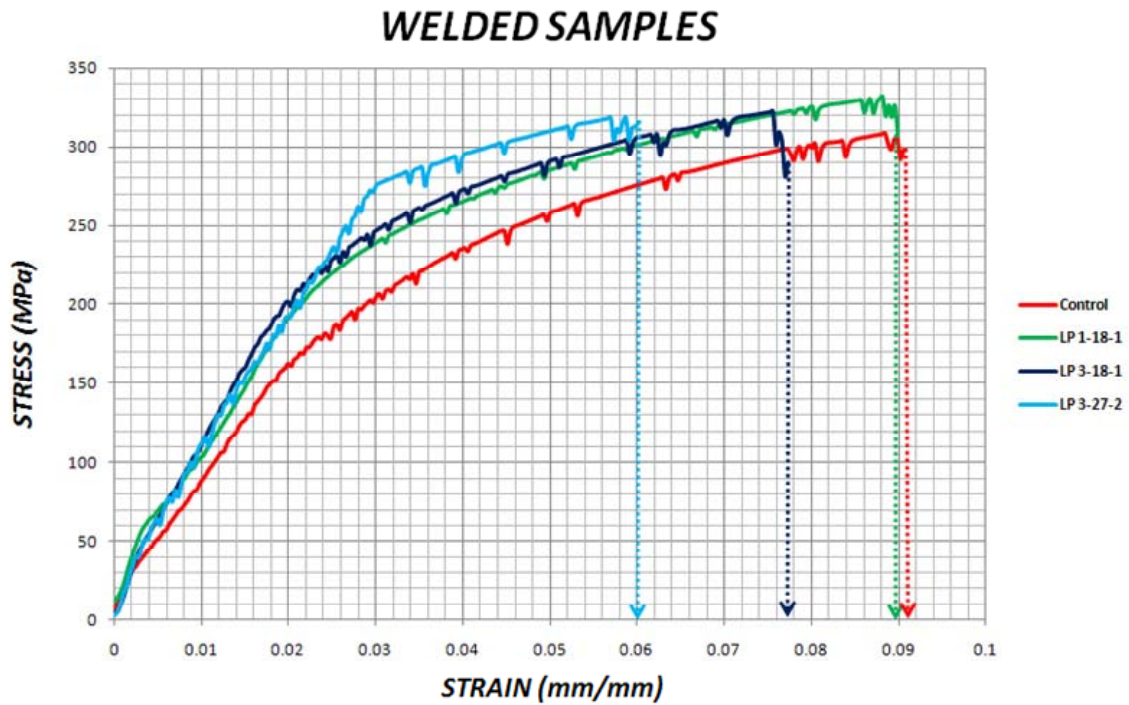
Figure 22. Welded samples stress strain curve.

The results of the SSRT tests for the welded samples, both control and laser peened are shown in Table 7. Figure 22 shows the stress strain curve for samples E, F, H, and M which correspond to the control sample, LP 1-18-1, LP 3-18-1, and LP 3-27-2. The aforementioned samples were chosen as a representative sample and display the full range of laser peened intensity starting with the lightest (LP 1-18-1) to the most intense (LP-3-27-2). The LP 3-27-2 had the lowest strain to failure and as the intensity of the laser peening decreased the strain to failure increased.

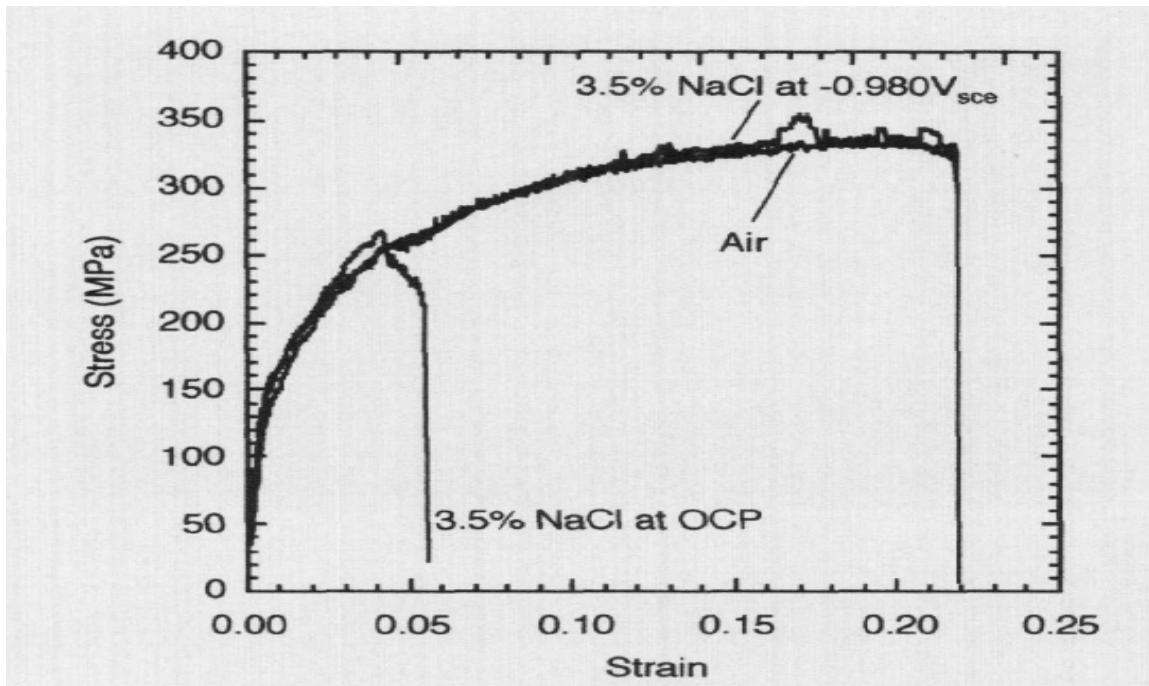
Figure 25. CERT data for 189 h sample showing ductility recovered at -0.980 V polarization during testing (From [22]).

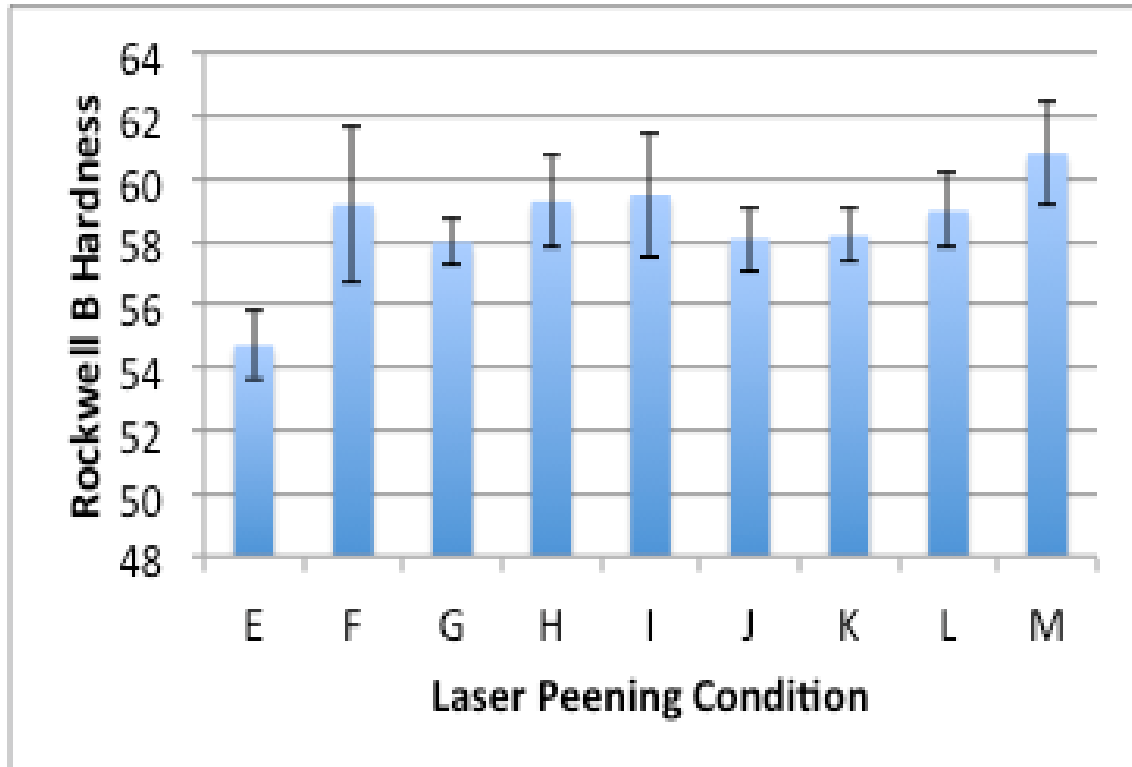
Figure 27. Rockwell B hardness data on base metal on unpeened material (sample E) and peened material (sample F-M).

E) as seen in Figure 27. Only laser power, or irradiance ( $\text{GW}/\text{cm}^2$ ), has a significant ( $t=2.63$ ,  $p<0.05$ ) effect when describing the variance in hardness. Hardness increases with increasing irradiance.

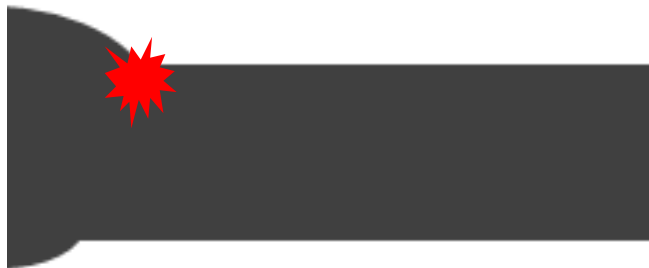
Figure 28. Vickers hardness as a function of position across the weld for the control weld and LP 3-27-2. The red indicator on the below diagram (the base of the HAZ) aligns with the 0 point on the distance axis.

The microhardness data was then gathered across the weld through the HAZ into the base metal using the Vickers Hardness test. Figure 28 compares the microhardness data and the most intense laser peened condition, LP 3-27-2. The control weld displayed a typical hardness profile with a softer area in the weld and into the HAZ. There is only slight increase in hardness in the base metal but a qualitatively large difference in hardness in the welded region and the HAZ. LP appears to even out the hardness profile of the HAZ into the weld, making a more uniform hardness profile throughout the sample.

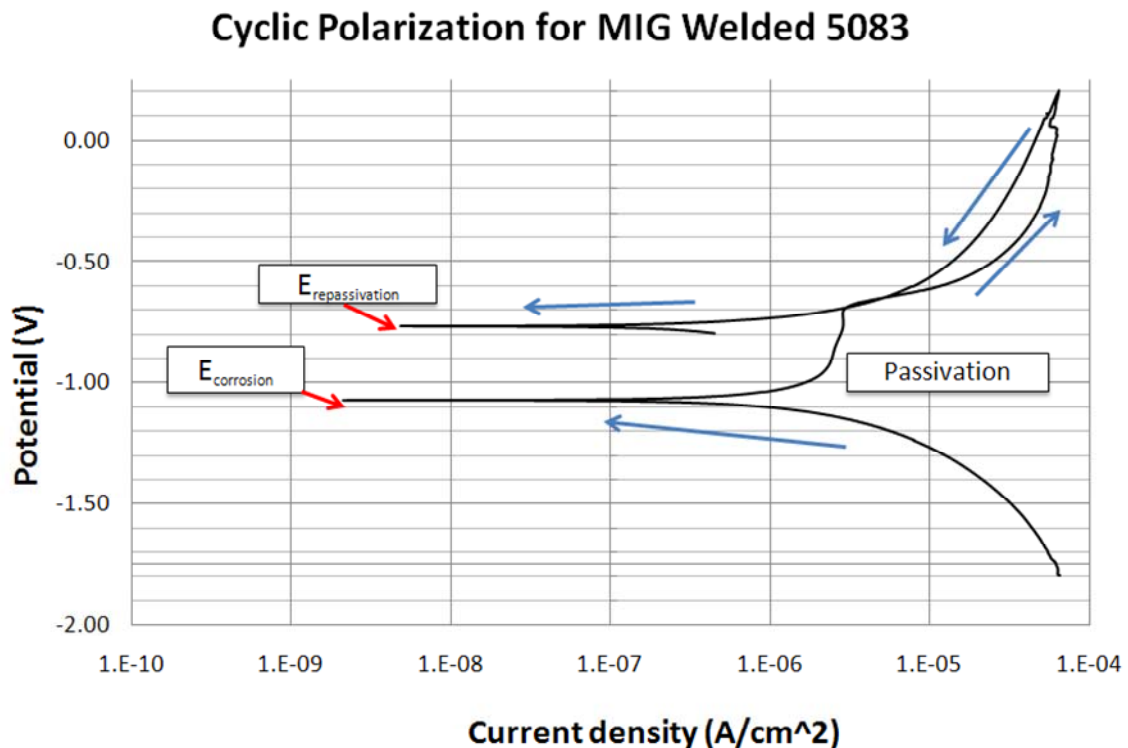
Figure 29. Polarization curve from combine control weld and 1-18-1 laser peened sample using custom-designed potentiostat described in Figure 30.

The cyclic polarization curve measured in the potentiostat described in the Experimental Methods section resulted in a result typical for AA5083 (Figure 29). The corrosion potential,  $E_{\text{corr}}$ , was measured to be approximately -1.1V. A clear passivation region was exhibited as the potential was increased from -1.1V to approximately -0.7V. Further increase in voltage displayed active corrosion. Upon potential reversal at +0.2V, a hysteresis was observed in the curve due to repassivation. The repassivation potential,  $E_{\text{repassivation}}$ , was measured to be approximately -0.8V.
