Morphological response of variable river discharge and wave forcing at a bar-built estuary

Orescanin, Mara M.; Coughlin, Jillian; Young, Walter R.

Naval Postgraduate School, Department of Oceanography, United States

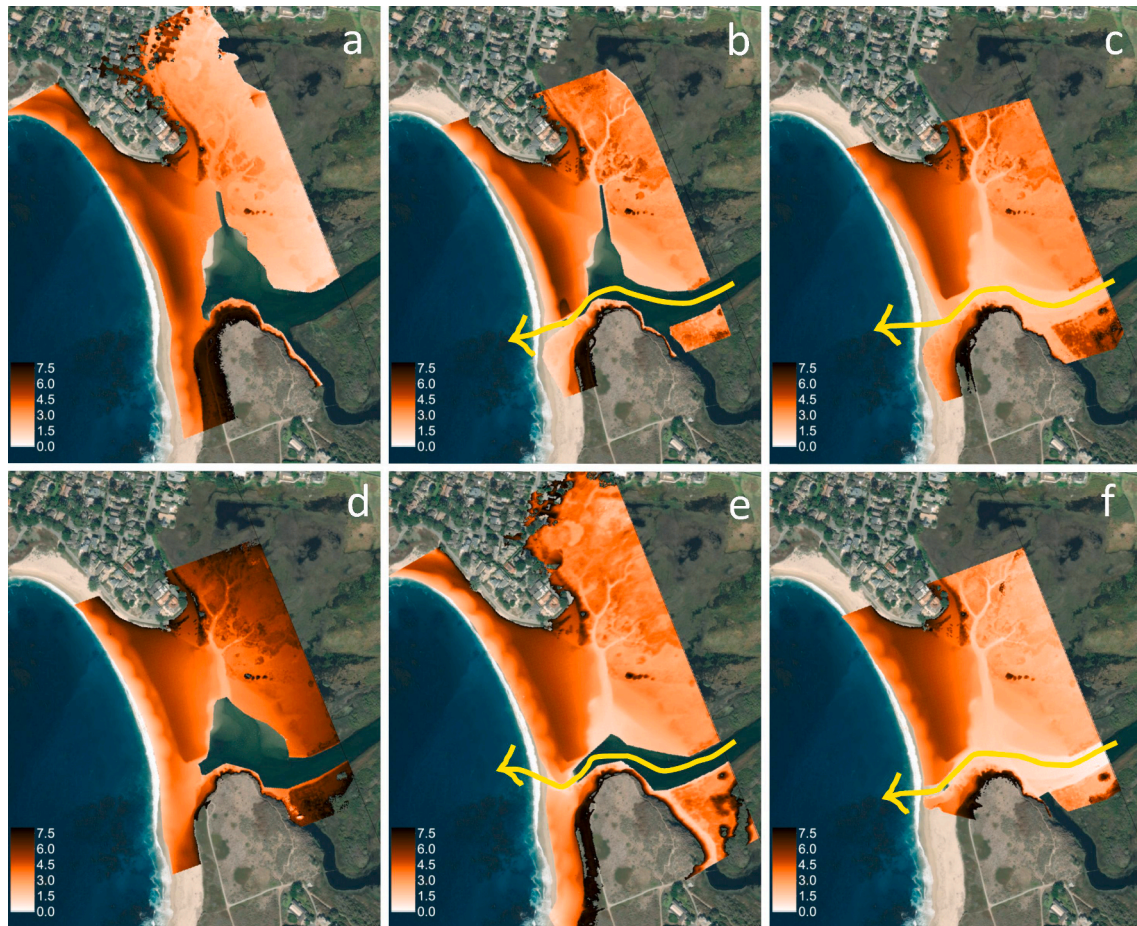
Fig. 7. Morphological evolution (2017–2018) for a) December 6, 2017; b) January 10, 2018; c) January 23, 2018; d) February 28, 2018; e) March 7, 2018; f) May 17, 2018. Elevations provided for above water level in m, NAVD88. Errors provided in Table 3. All colored regions are areas exposed (sand) while any gaps in surveys were fully submerged (parts of the channel and/or lagoon). When the breach shifted along the beach, the data have been removed as the camera is unable to accurately distinguish depths through water. Yellow arrows indicate location of an active breach channel when present. (For interpretation of the references to color in this figure legend, the reader is referred to the Web version of this article.)

In contrast to the previous season, the 2017–2018 breach season did not migrate from its initial breach location to the south (Fig. 7), and instead showed a net increase in beach elevation on the back beach (Fig. 4b). Consequently, the cross-sections for this season (Fig. 8) show less variation between survey dates. The initial breach of this season was an artificial breach conducted by Monterey County Resource Management Agency on January 9, 2018 (sand pile visible on the north side of the channel in Fig. 7b). However, the breach was not stable and closed within a few days. The first natural breach occurred on January 21, 2018.

From December (Fig. 7a) to early January (Fig. 7b), there is very little change across the beach, aside from the evolution of beach cusps. Between the early January (Fig. 7b) and February (Fig. 7c) survey flights, the back beach elevation increased by 1–2m at the middle and northern portions of the beach (also seen in Fig. 8a and b), erasing the
