Case study of Alachua County Detention
Facility renovation.

CASE STUDY OF ALACHUA COUNTY DETENTION
FACILITY RENOVATION

A REPORT PRESENTED TO THE GRADUATE COMMITTEE
OF THE DEPARTMENT OF CIVIL ENGINEERING IN
PARTIAL FULFILLMENT OF THE REQUIREMENTS FOR
THE DEGREE OF MASTER OF ENGINEERING

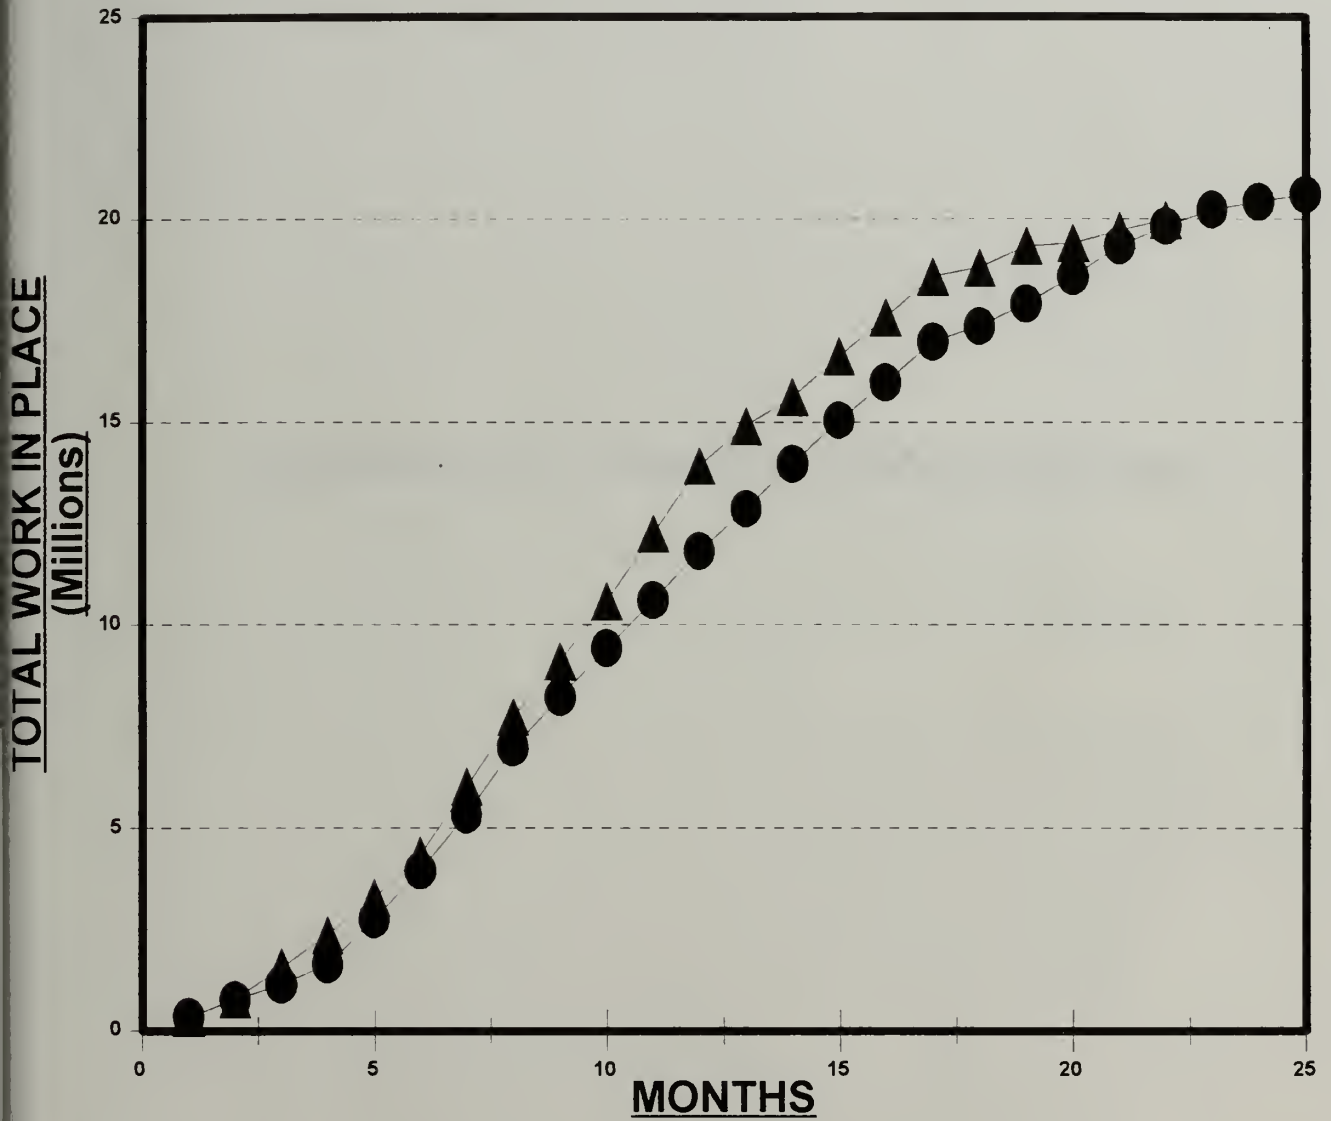
● PROJECTED TOTAL WIP ▲ ACTUAL TOTAL WIP
