# Impact analysis of low velocity to composite box containing water

NPS-MAE-16-001

**IMPACT ANALYSIS OF LOW VELOCITY TO COMPOSITE BOX  
CONTAINING WATER**

Taylor J. South, Kyoung Jae Yun and Young W. Kwon

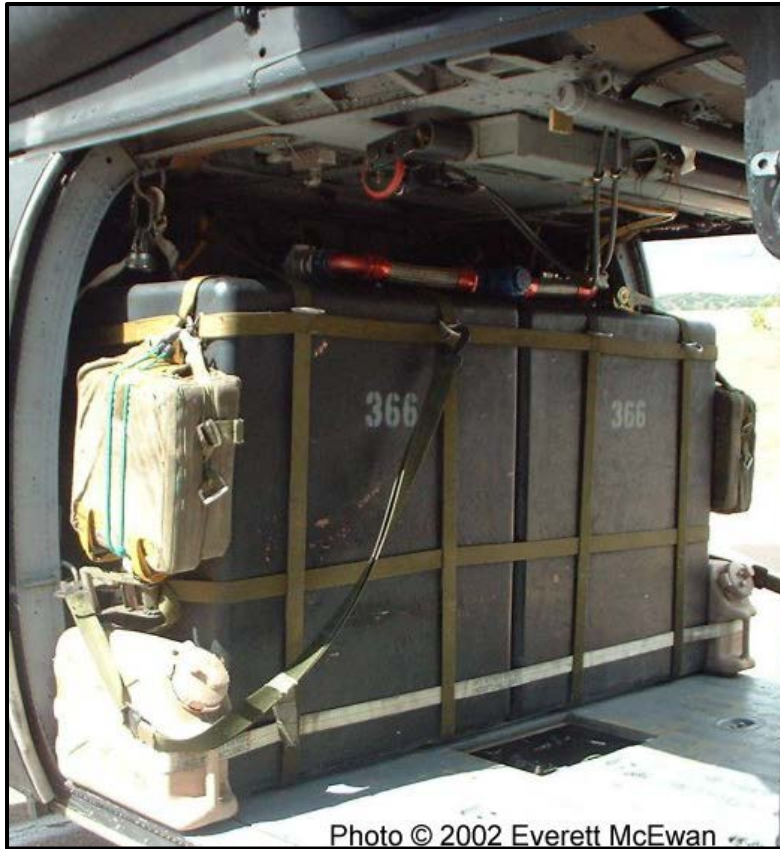
Figure 1. Fuel cell on MH-60 Blackhawk helicopter[3]

Composite materials are becoming increasingly popular as they provide high stiffness and strength with low weight. They have a range of applications in the commercial and defense sectors, especially in the aerospace and marine environment. As these applications are usually in a dynamic setting, impact loading is a major area of interest. Composite structures are generally more vulnerable to impact damage than metallic structures due to their reduced hardness and ductility. These properties allow metals to absorb greater amounts of energy without failure [1]. In addition, as composite structures are generally more flexible, greater deformation can occur following an impact. This can be a very important consideration when the composite structure is in close proximity to other structures or components. For instance, due to the limited space in an aircraft the fuel cell is often situated close to vital components. In the event of impact to the fuel cell, large deformations in the structure could cause unwanted contact with the adjacent components. Even if failure does not occur in the composite structure, the dynamic response to the impact could cause damage to adjacent components. Figure 1 shows a representative fuel cell in a military helicopter.

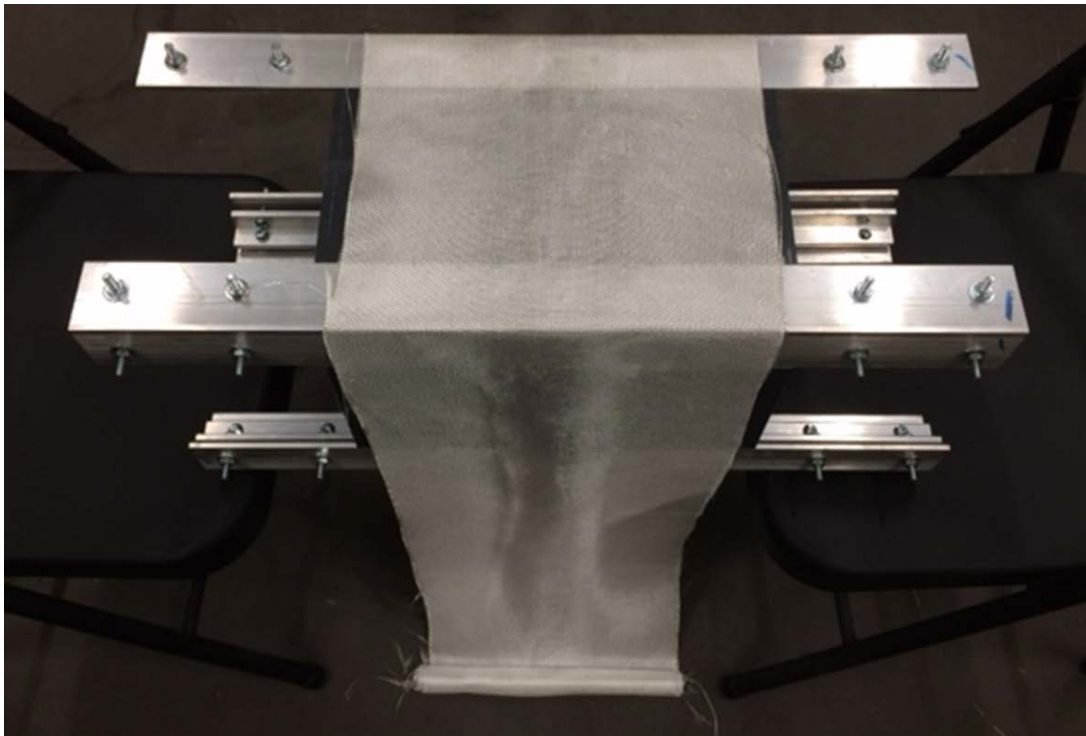
Figure 6. First layer of E-glass laid on form during fabrication

The form was positioned as to allow it to be rotated throughout the layup process, making the top surface the working surface. A layer of epoxy was laid to cover the wax paper and provide a surface to which the E-glass fabric could adhere. This process was repeated on each side of the form as the first layer of the E-glass was laid. Special attention was given to ensure that the first layer of E-glass and epoxy was tightly fitted around the form and especially at the corners. Figure 6 shows the first layer of E-glass fabric laid on the form.

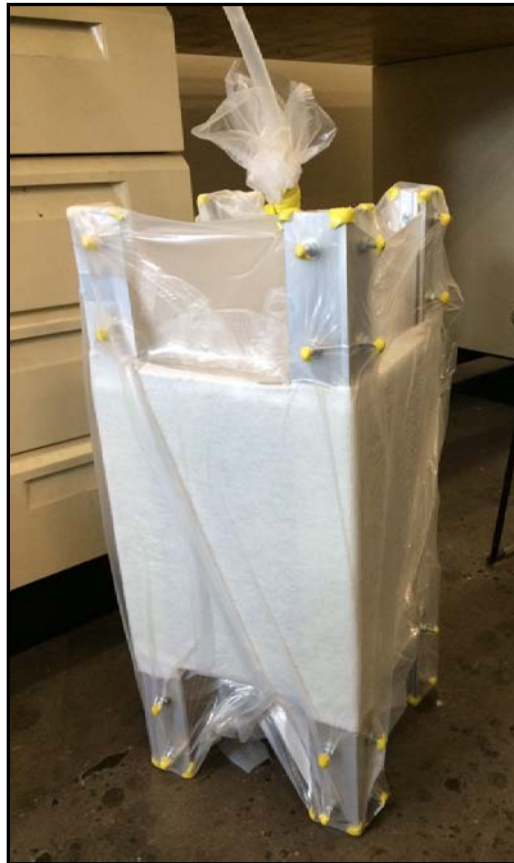
Figure 8. Form and composite under vacuum after layup

form and tearing. The vacuum hose was inserted and made air tight with double-sided gasket tape. Finally, the composite structure was placed under 68.95 kPa of vacuum and held for 1.5 hours. The composite structure under vacuum is shown in Figure 8.

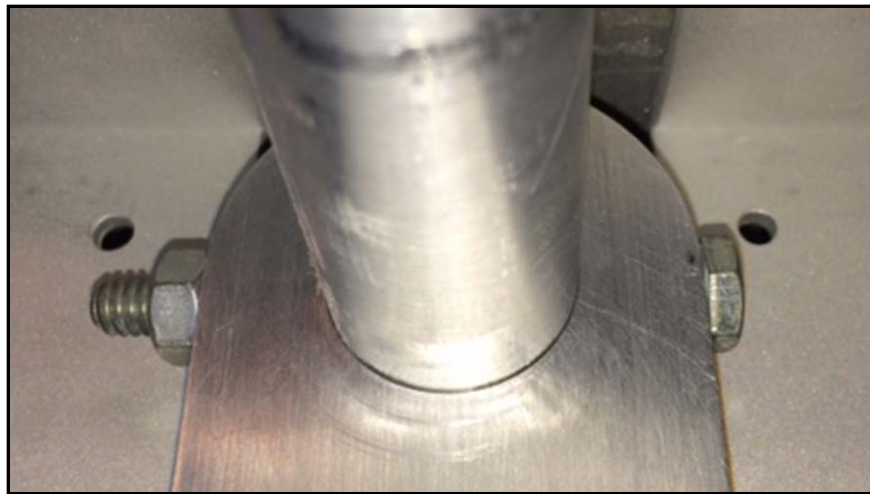
Figure 18. Attachment point for rotating rod and pendulum arm

The pendulum arm was fabricated from 6061 aluminum flat bar that measured 57.15 cm x 5.08 cm x 1.27 cm. At the top of the flat bar (arm) a 2.54 cm diameter hole was drilled to accommodate the aluminum tube (shaft). A 2.54 cm diameter hole was also drilled through the arm and shaft and fitted with a 0.9525 cm bolt and nut to bond the two pieces (Figure 18). A 2.54 cm radius was cut on the top of the arm to prevent contact with the mounting plate through the range of pendulum rotation.

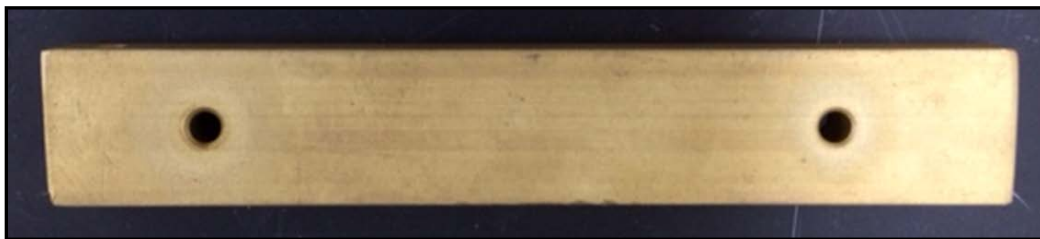
Figure 19. Brass weight attached to pendulum arm

At the bottom of the arm two holes were drilled on the back side to accommodate a brass bar for added mass. The brass bar, shown in Figure 19, measured 15.56 cm x 2.54 cm x 1.27 cm, and weighed 434.5 g. An additional hole was drilled on the front of the arm as a threaded connection point for the impactor. This hole was located 1.27 cm from the bottom of the arm; drilled to a depth of 1.27 cm and tapped for a 1/4-28 thread. The completely assembled pendulum arm is shown in Figure 20.

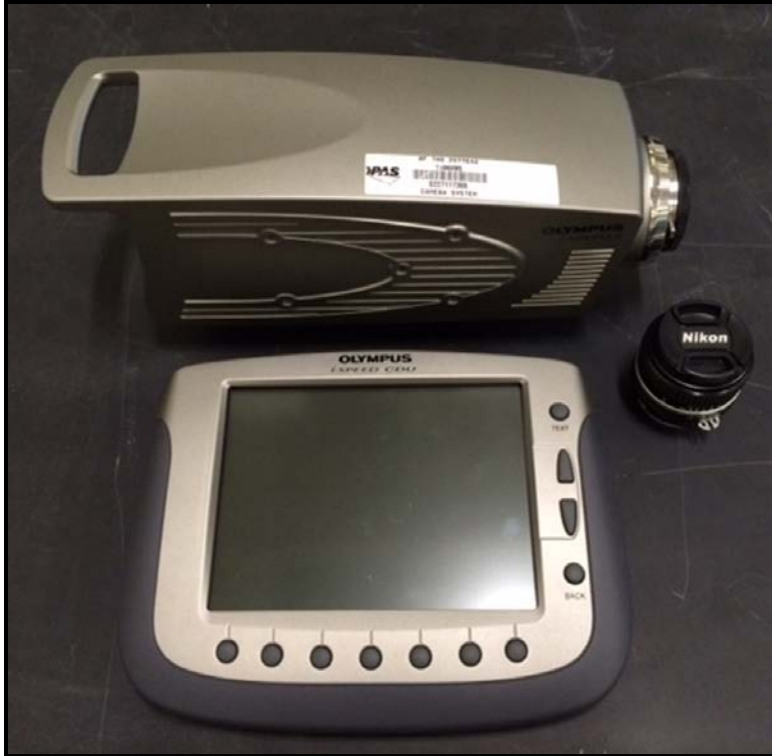
Figure 26. Olympus® high speed camera, screen, and Nikon® lens

To capture the deflection of the sides of the composite structure an Olympus® i-Speed 3 high speed camera fitted with a Nikon® Nikkor 50 mm lens (Figure 26) was used. During testing, the camera was set-up to capture high speed video of the motion on the front (impact) side and back side. For these videos the camera was located at approximately a 45 degree angle from the respective face. Additionally, the motion of all sides and fluid motion was captured with the camera set-up directly above the structure as shown in Figure 27. The camera was set to capture the motion of the structure at 1,000 frames per second (fps).

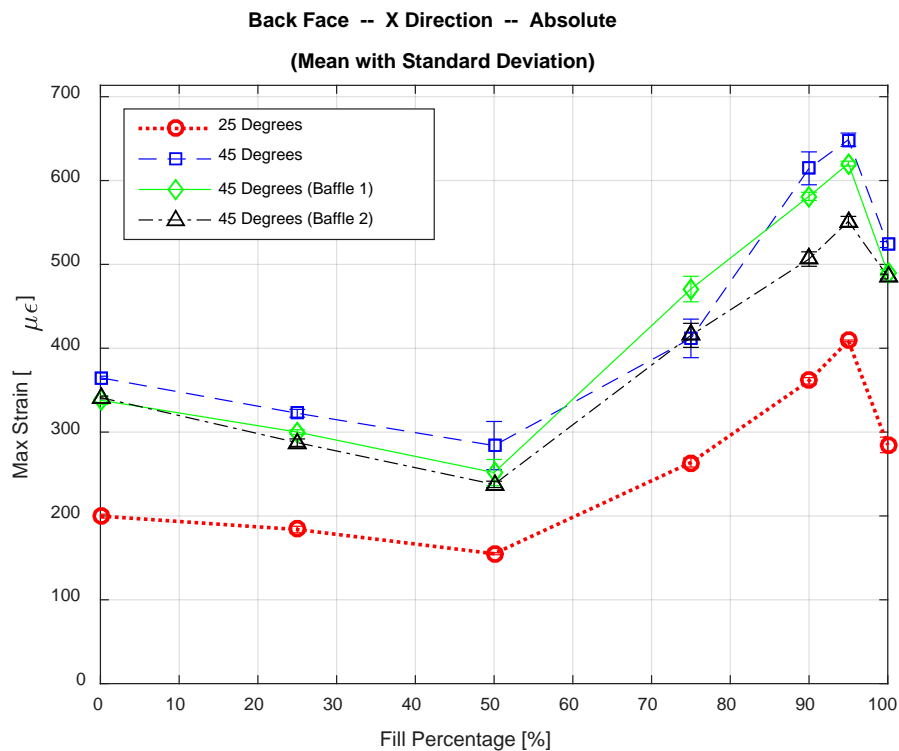
Figure 37. Plot of the maximum strain at the back surface vs. water fill level

Figure 37 plots the maximum strain in magnitude at the back surface as a function of the water level. All the maximum strains were in tension. The 50% full case had the smallest strain while 95% full case had the largest strain. The 90% and 95% full cases had the maximum strain which was more than twice of that of the 50% full case. The standard deviation was also plotted in Figure 37. The 50%, 75% and 90% full cases have larger standard deviations than other cases. Especially, the 50% full case showed the largest standard deviation.

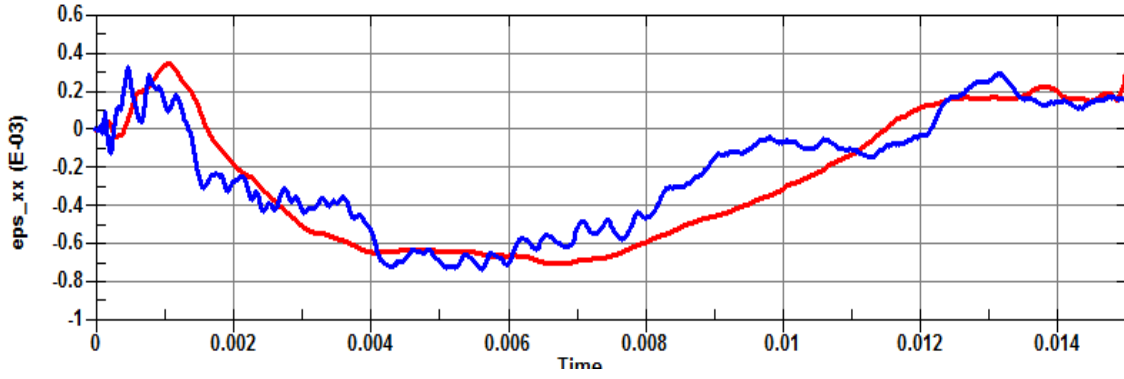
Figure 41. Comparison of strains at the front surface between the numerical and experimental results for empty box

The next study was the numerical result. The numerical results were compared to the experiment data so as to validate the model. Figures 41 and 43 compare the strains in the 0% filled water (empty) composite box. And Figures 44 and 46 compare the strains in the 50% filled water composite box. Finally, Figures 47 and 49 compare the strains in the 100% water-full composite box. The comparison was made at the front surface, side surface, and back surface of the empty box, 50% water filled box and the 100% water-full box, respectively.

The numerical results agreed well with the experimental data. Then, the transverse displacement at the center of the back surface was compared between the empty and 100% water-full boxes as seen in Figure 50. The internal water reduced the oscillatory motion of the back side significantly. The comparison showed that the 100% full water yielded much greater displacement with one order magnitude.

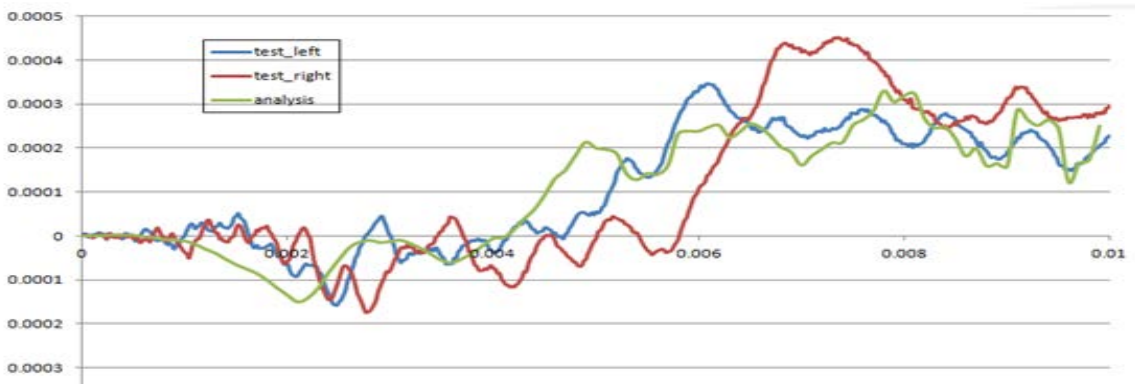
Figure 48. Comparison of strains at the side surface between the numerical and experimental results for box with 100% full water

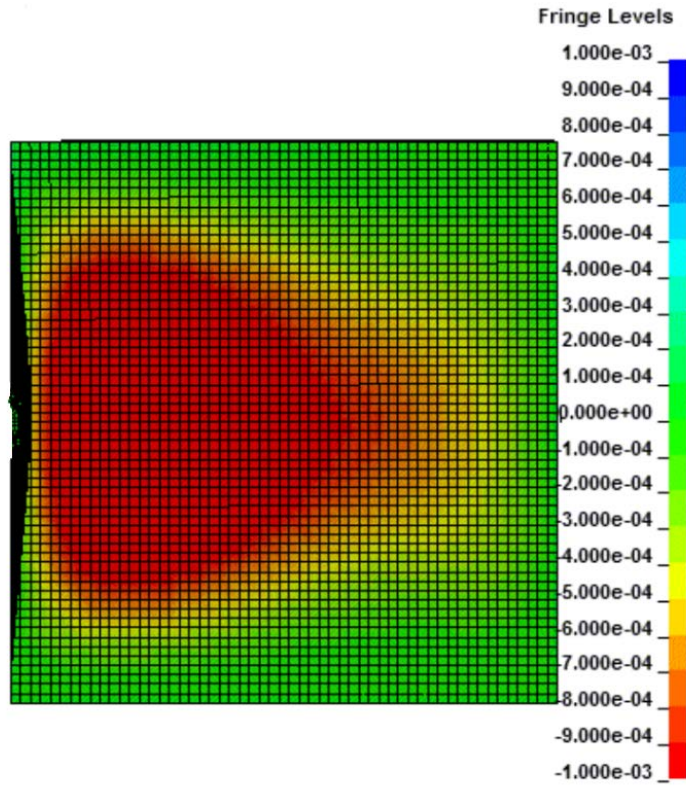
Figure 53. Comparison of contour plots of the side surface deformation (a) without water and (b) with 100% water

Figures 51 through 53 compare deformation contours at the front, side, and back surfaces with 100% full water and without water. The deformations of the front surface were similar between the two cases at least qualitatively as shown in Figure 51 even though they were different quantitatively in terms of magnitude and frequency. Both cases vibrated in the first mode shape because the impactor hit the center of the plate. However, the side and back surfaces showed very different contour patterns. The more uniform deformation was caused by the water. Finally, the back surface has drastically different contours with and without water. The back surface without water vibrated more or less randomly while the water resulted in more regular shape of vibrations as sketched in Figure 52. The side surface without water showed asymmetric contours with larger deformation toward the impact side while the side surface with water exhibited more or less symmetric contours as shown in Figure 53.
