THESIS

**DYNAMIC FAILURE OF SANDWICH BEAMS WITH FLUID-
STRUCTURE INTERACTION UNDER IMPACT LOADING**

**DYNAMIC FAILURE OF SANDWICH BEAMS WITH FLUID-STRUCTURE
INTERACTION UNDER IMPACT LOADING**

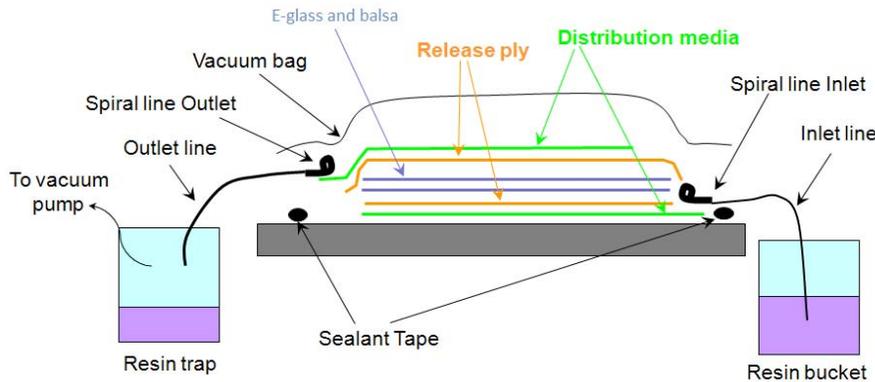
The composite test panels were constructed to match, as closely as possible, the industry standard used in today's marine construction. The test panels were constructed using a vacuum assisted resin infusion process (VARTM) shown in Figure 1.

Figure 1. VARTM setup (After Owens)

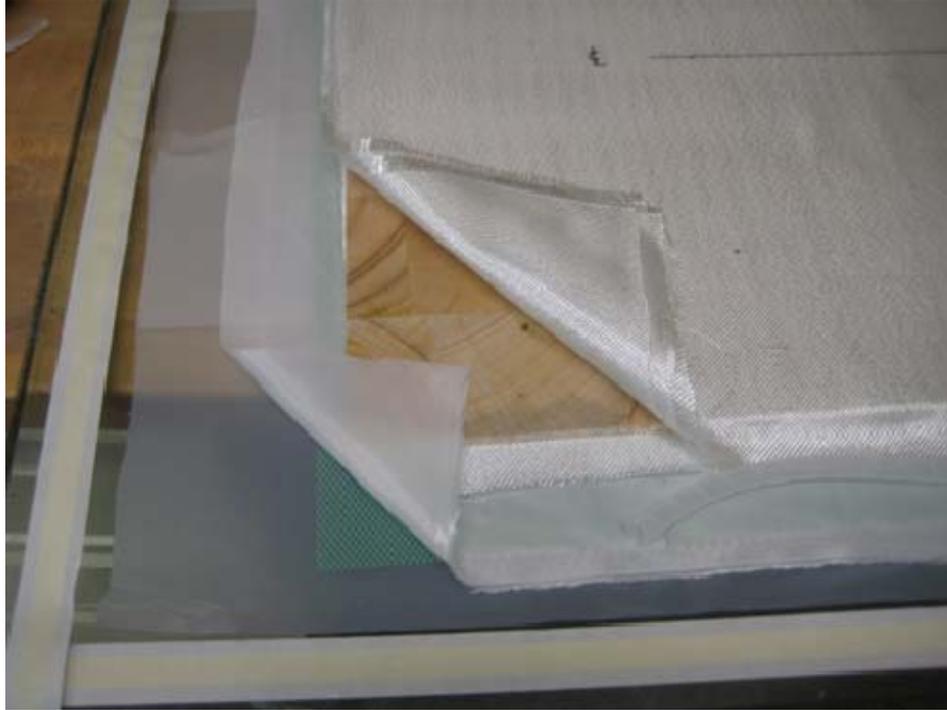
Step 4: Layup material in the following order from bottom to top: distribution medium (required on mold side since skin thickness limits resin flow), peel ply, 3 sheets of E-glass, fibers aligned, balsa core, 3 sheets of E-glass, peel ply, distribution medium, peel ply (to protect the vacuum film from the cut edges of the distribution medium.) Figure 2 shows the beginning of this layup sequence.

Figure 2. Dry layup, bottom to top: Teflon, distribution medium, peel ply, E-glass, Balsa Core, E-glass. Not yet added: peel ply, distribution medium, vacuum film.

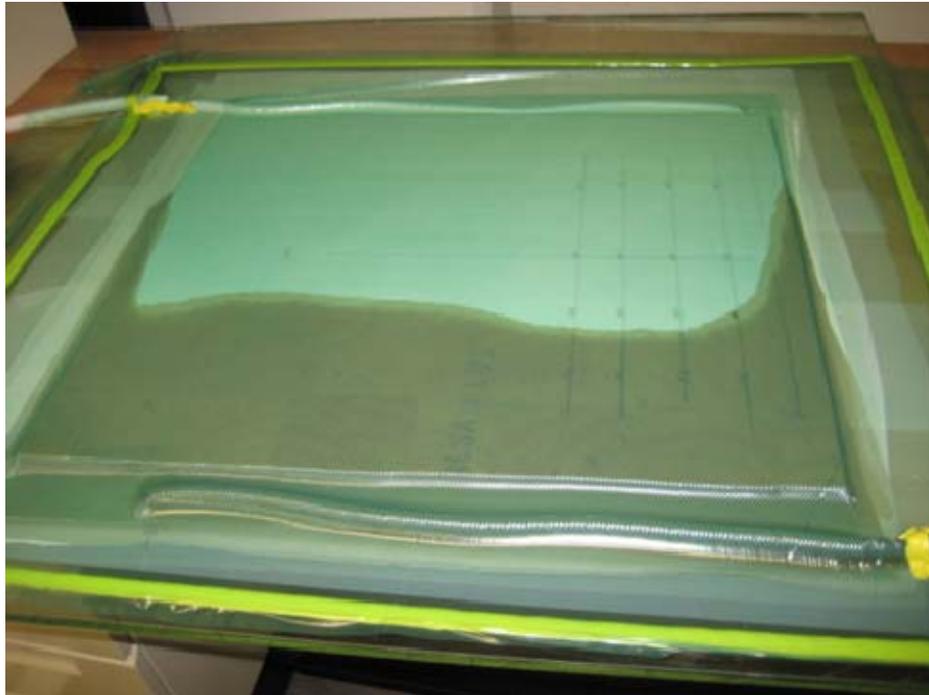
Step 10: Pour mixed resin into feed container and break the feed hose seal. Resin will be drawn through the feed hose, into the spiral wrap and across the sample as shown in Figure 3. Check for air leaks and plug them with extra sealant tape.

Figure 3. Resin flowing through the layup

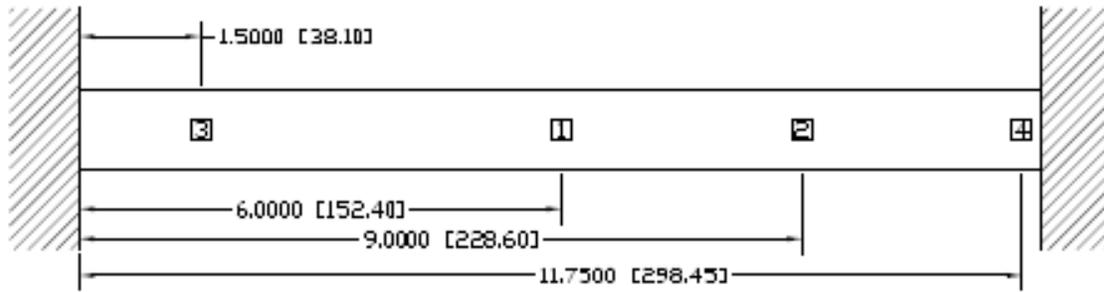
Strain gages were placed at mid span, quarter span, eighth span, and on the free side of the clamped support boundary as depicted in Figures 4 and 5.

Figure 4. Strain gage placement (Unit in inches followed by millimeters in parentheses)

A small number of coupons were prepared with uni-directional strain gages as part of the layup as shown in figure 4. This application technique showed good adhesion and resilience through multiple impacts. It also had the advantage of placing the gages directly on top of the outer ply of E-glass rather than attempting to glue the gage to the outer resin layer that has taken the shape of the peel ply weave. One of the drawbacks to this technique is the difficulty in maintaining alignment during the dry layup. Once the vacuum is drawn, however, flowing resin does not appear to displace the gages.

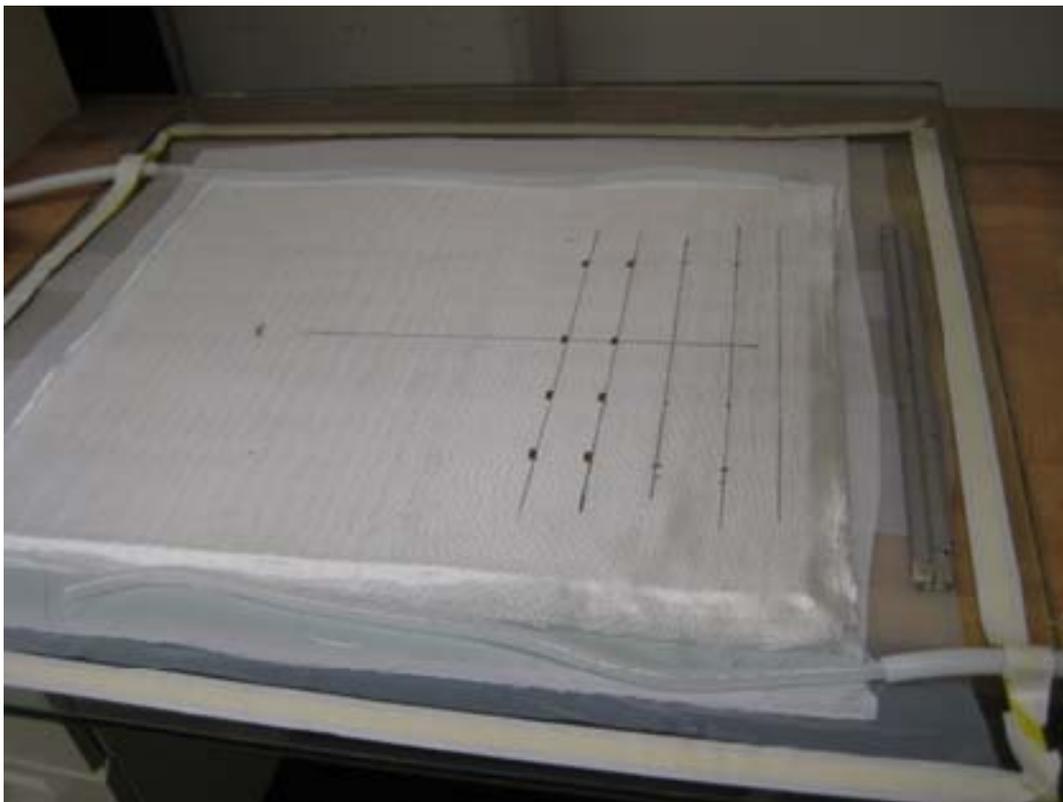
Figure 5. Strain gage placement on dry layup

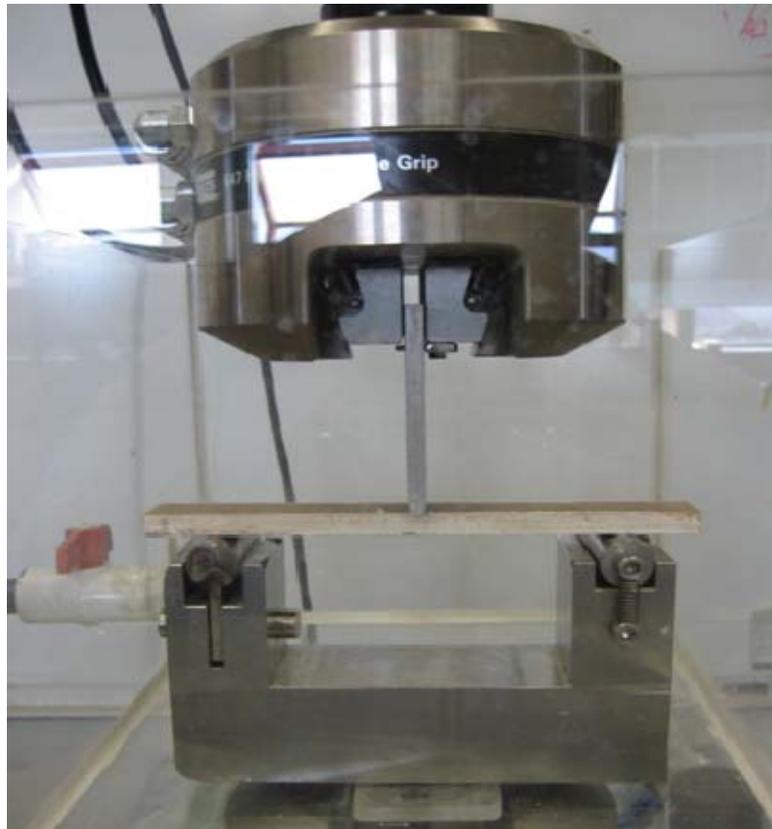
This stainless steel fixture was constructed in the NPS machine shop with a span of 152.4 mm (6 in) and a depth of 50.8 mm (2 in) to conduct testing in accordance with ASTM D 709 [17]. The fixture was attached to the hydraulic grips via a squared stud threaded into a hole tapped in the center of the bottom of the fixture. The 50.8 mm (2 in) wide center point is composed of 6.35 (0.25 in) mm aluminum stock with a radius milled along the contact edge. Figure 6 shows the fixture with coupon in place in the submersion tank.

Figure 6. Three-point bending fixture

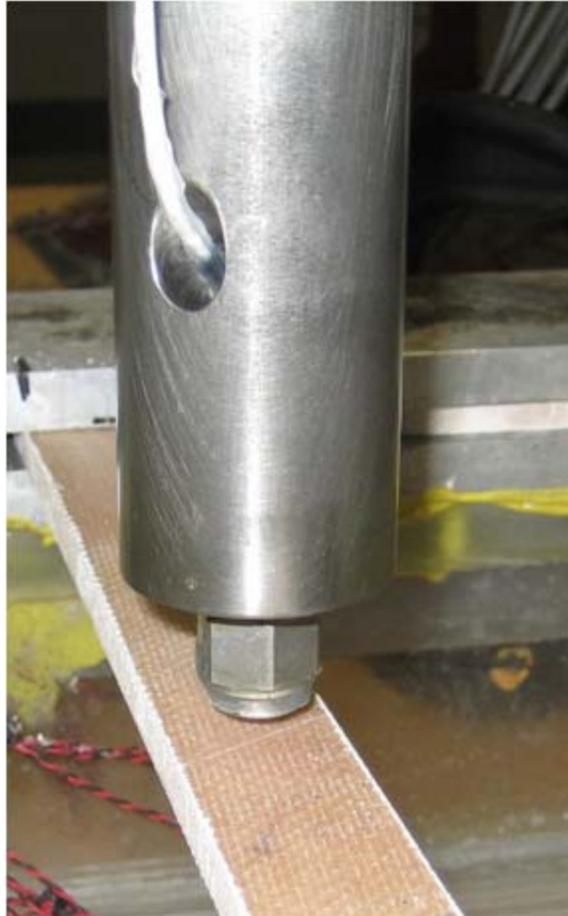
The load cell was an ICP® force sensor manufactured by PCB Piezotronics, Inc., which converts force into a measurable electrical output. The load transducer was mounted on the end of the impactor rod, as shown in Figure 7. The gage had a diameter of 16mm. In order to increase longevity in an aqueous environment, both the gage and cable connection were coated with M coat A bond. Additional waterproofing was provided by a thin latex sleeve fitted over the end of the impacting rod.

Figure 7. Piezo electric load cell

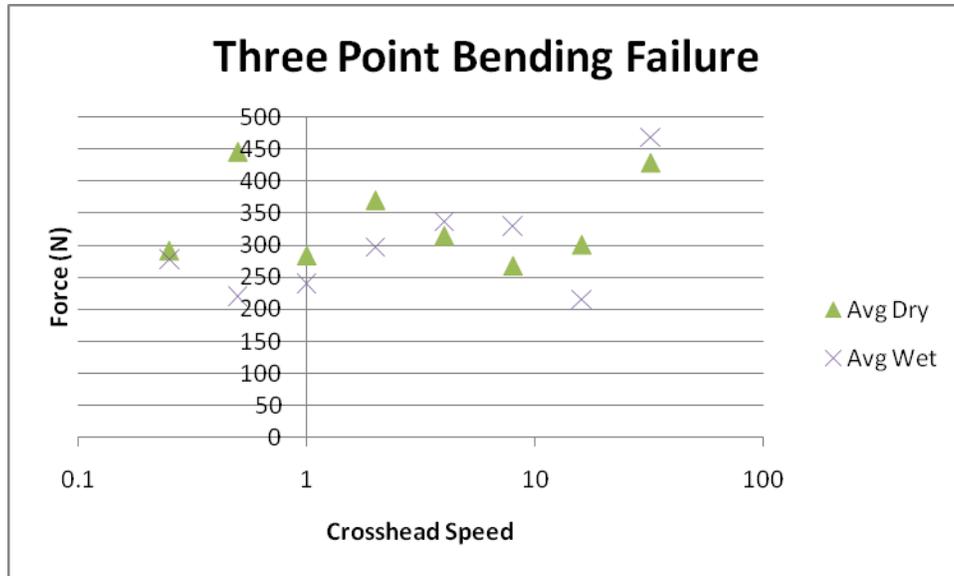
Figure 8. Failure force verses crosshead speed (untreated balsa)

Over 100 samples were tested using ASTM method D 709 for three point bending [17]. Strain rates were varied from sample to sample, but remained constant for any one test. Strain rate is assumed to be proportional to crosshead speed based on the equation for stress at the outer fiber where displacement is replaced by velocity [18]. Failure always occurred on the top surface at or near centerline. Mode of failure was skin compression, occasionally accompanied by local indentation. Delamination was occasionally seen, particularly at high strain rates. Data showed significant scatter due to inconsistencies in the balsa core and no correlation could be established between wet and dry samples (Figure 8). However, there was a general strengthening trend with increased crosshead speed, which is consistent with previous findings. A final test using hot coated balsa at two strain rates, one high and one low (Figure 9), had much tighter grouping with no outliers. This test supported the trend observed in previous tests and was judged conclusive that water medium did not affect the stress strain curve under a constant strain rate, i.e., without the inertia effect.

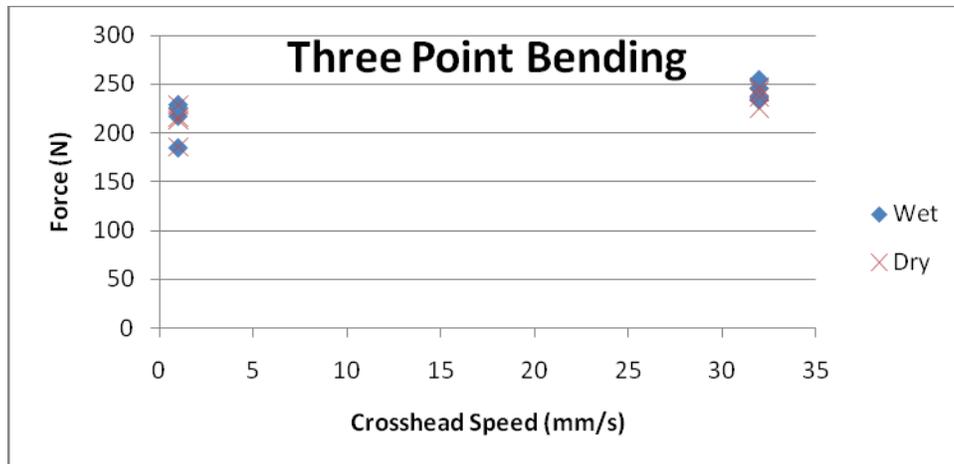
Figure 9. Medium has no effect of failure load but increasing strain rate increases ultimate strength. (hot coated balsa)

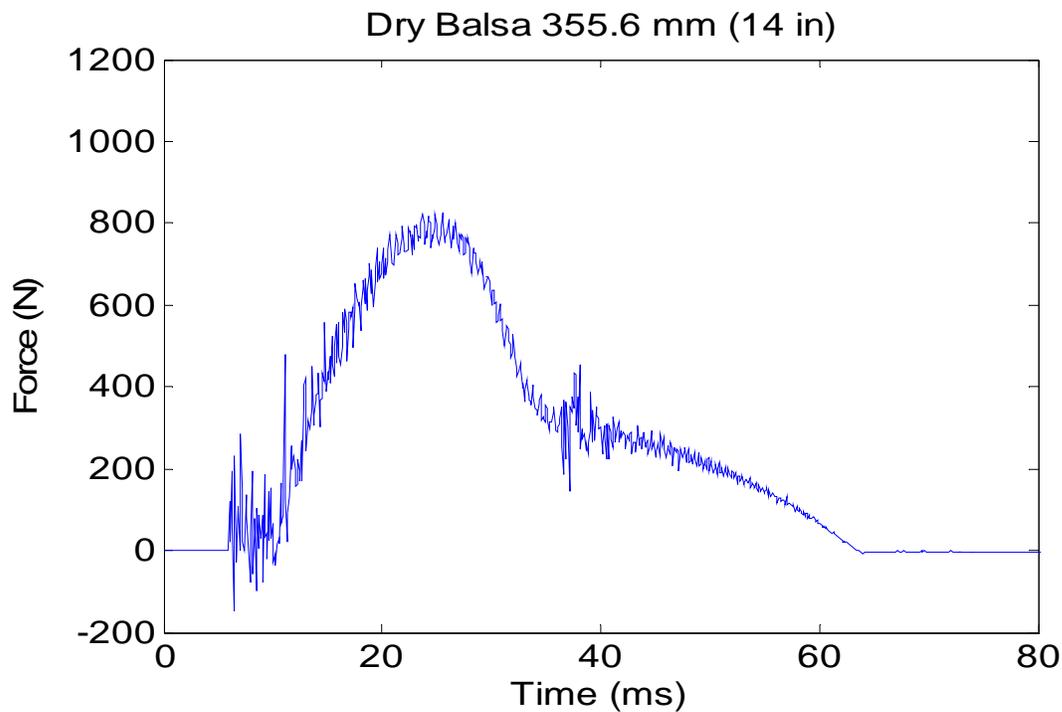
The force/time graph of all dry failures show a high frequency response with an average period of 0.6 ms (Figure 10.) This frequency is observed on every test, regardless of damage. When failure can be seen on the plot, it typically occurred at the peak of the force plot with an abrupt drop in force as depicted in Figure 11.

Figure 10. Dry Balsa with no damage

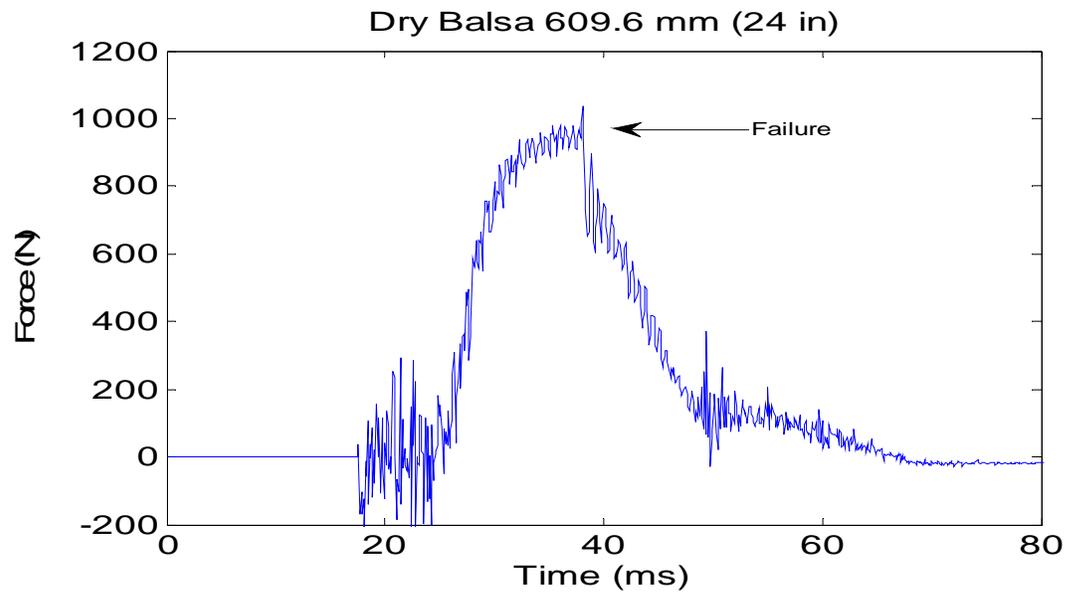
Figure 11. Dry Balsa Failure

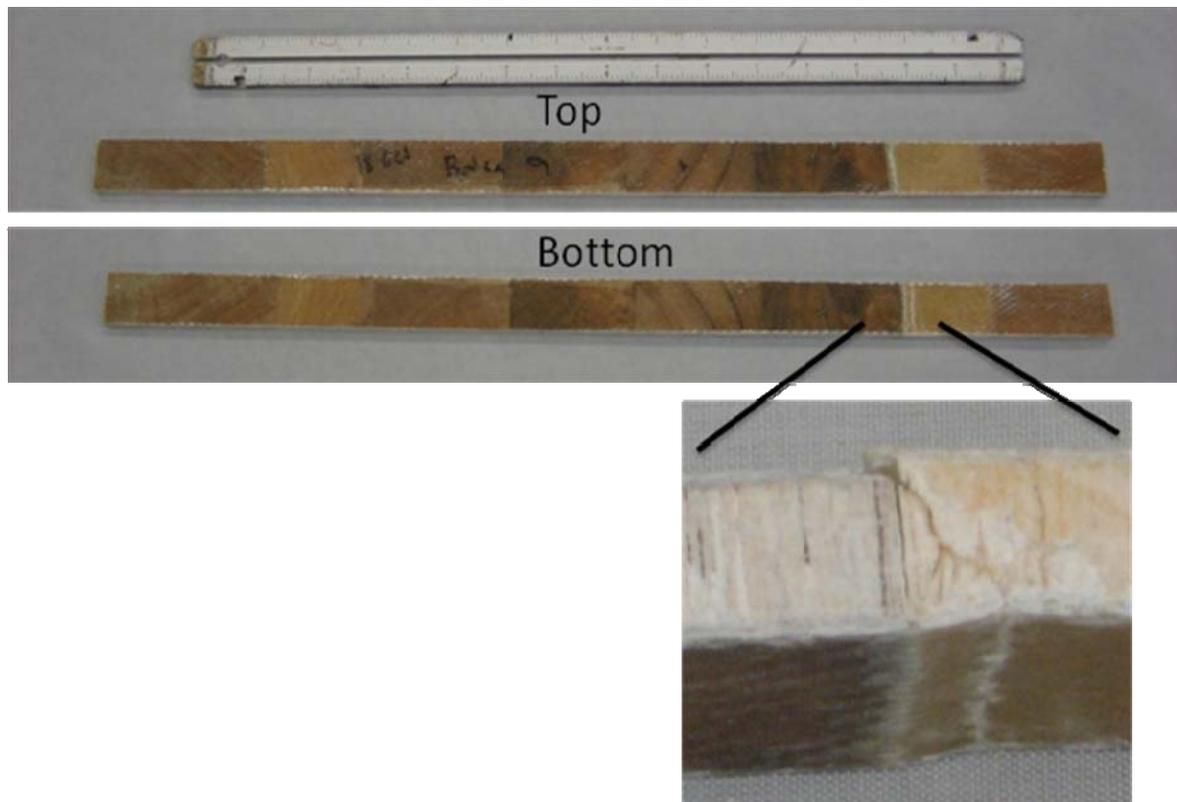
Dry failure mode is dominated by skin failure in compression on the bottom of the beam at either boundary edge. Some samples also showed evidence of shear failure in the core at the same point such as the sample in Figure 12. Many samples had no evidence of any damage whatsoever at the mid span point of impact.

Figure 12. Dry impact damage with core shearing. The rightmost fracture line was right at the edged of the clamped boundary.

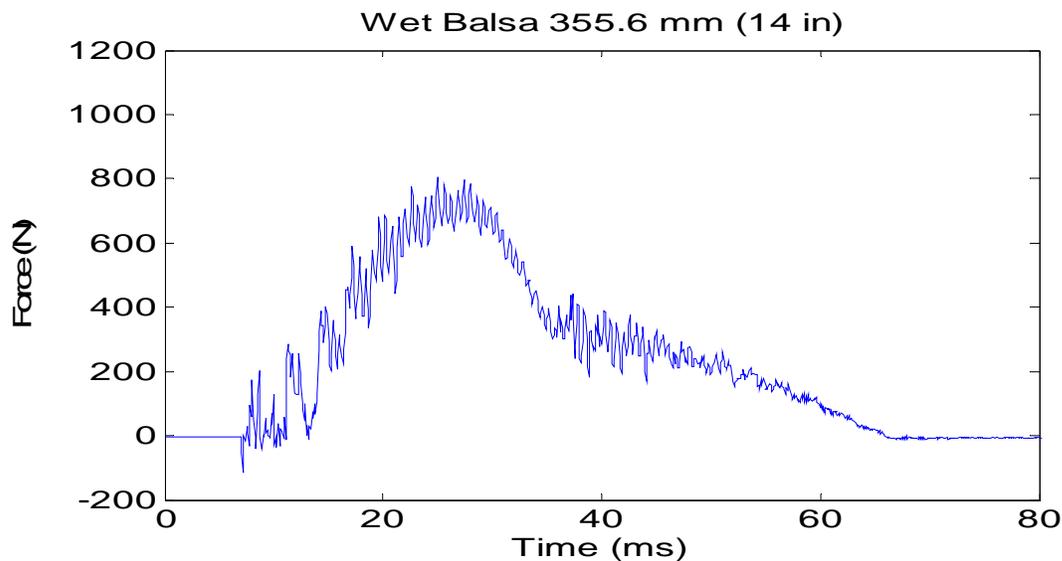
The force/time plots for submerged samples show a high frequency response with an average period of 0.6 ms similar to dry testing. However, the submerged samples also exhibited a secondary frequency response with an average period of 2.5 ms. This mode had greater amplitude than the 0.6 ms mode and can easily be seen in Figures 13 and 14. Failure often occurred after the force had peaked (Figure 14.)

Figure 13. Submerged impact without failure

Additionally, when subjected to equal impact velocities, the submerged samples absorbed on average 7% more force than the dry samples due to the inertial effect of the fluid resisting acceleration (Table 8) of the beam structure. There is also an indication that the inertial force imparted by the fluid caused submerged beams continued to deflect after the peak impact force resulting in the failure after peak force as shown in figures 13 and 18.

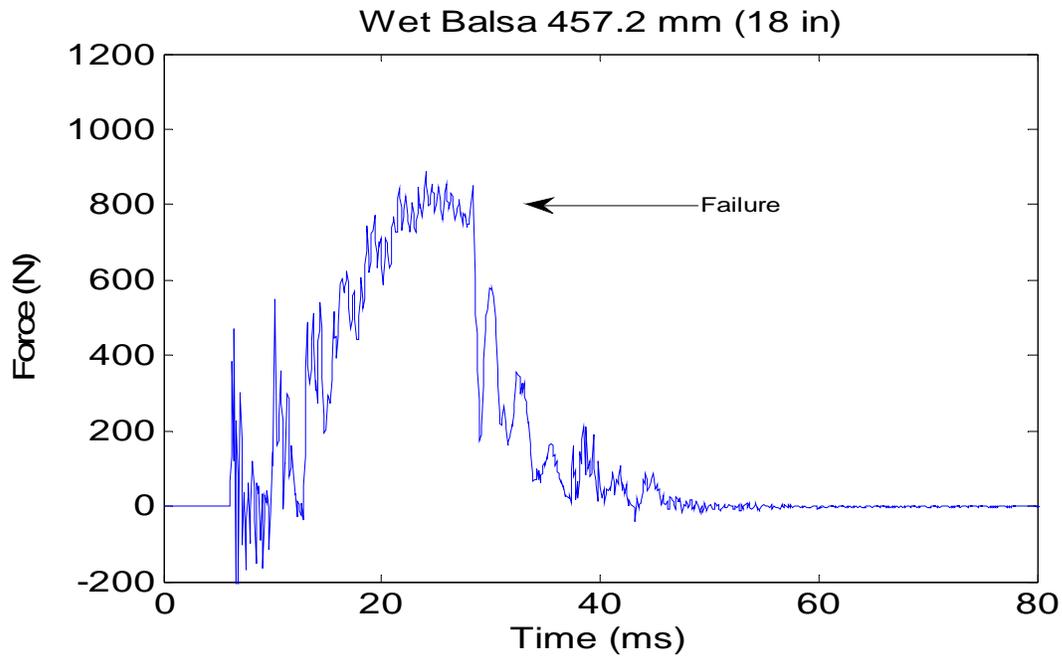
Figure 14. Submerge impact failure.

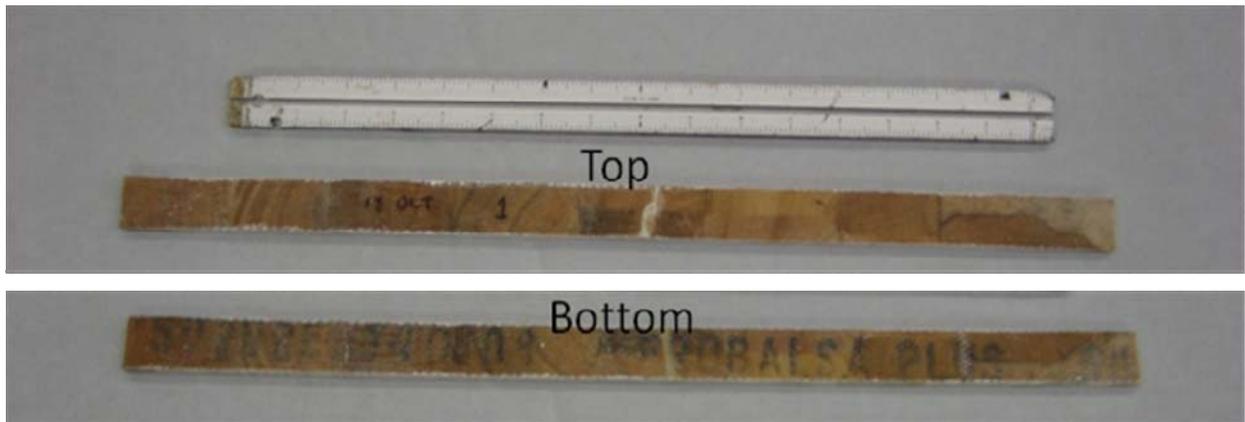
Submerged impact damage was primarily observed at centerspan with some damage also occurring at the edges of the beam. Failure mode was skin compression adjacent to the point of impact on the top skin with some localized delamination as seen in Figure 15. Any core damage at these sites was from bending, and did not show any sign of impact compression because the vertical cellular structure of the balsa was completely intact, but there was indication that the balsa had been compressed longitudinally, ie, across the grain. There was no evidence of water intrusion at any point. Submerged impact damage at one or both ends often appeared in the form of skin compression without evidence of shear failure in the core.

Figure 15. Typical submerged impact damage.

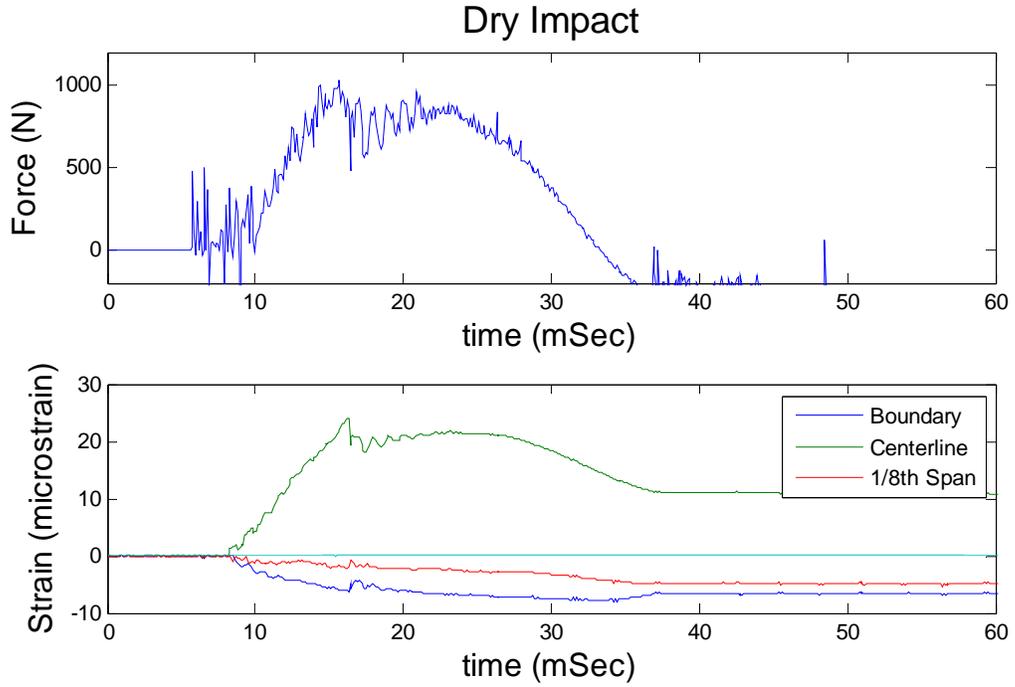
Figure 16 shows a dry impact which failed both on centerline and at the boundary opposite the boundary strain gage where 8.1 ms elapse from first strain response to peak strain. Figure 17 shows a submerged impact with failure on centerline. While the centerline strain gage follows the force profile, the amplitude is clearly not correct. Elapsed time from first strain response to peak strain was 11.9 ms. Figure 18 shows a submerged impact that did not fail. The centerline gage shows greater amplitude than the boundary gage, and is indicative of what is expected for a submerged impact. Figure 19 shows a submerged mid-span failure from a drop height of 609.6 mm (24 in). This drop was required to achieve failure as previously discussed. Figure 20 shows a submerged boundary failure. This plot indicates an early failure at the boundary followed by some residual strength in the rest of the beam. Figure 21 shows a combined failure from 762 m (30 in) drop height. This is an obvious outlier that took progressive impacts to achieve failure. This is the same sample from Figure 18.

Figure 16. Dry impact, centerline and boundary failure

again, but was not as successful, perhaps because the panel with the second batch of strain may have been opened prematurely. Despite some inconsistent data, the results are still worth examination (Figures 16, 17).

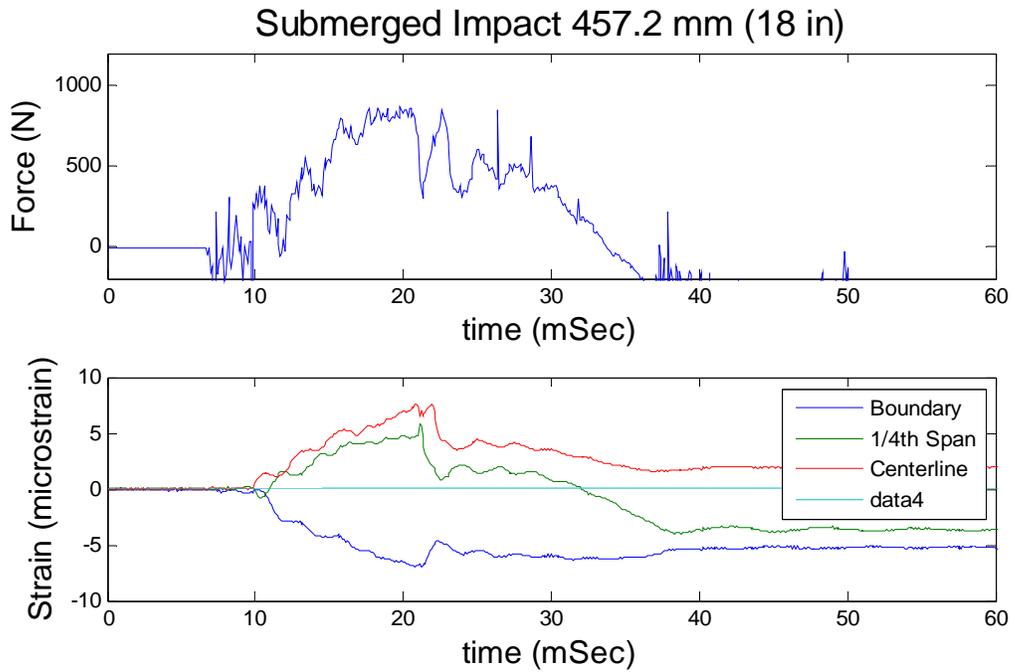
Figure 17. Submerged impact, centerline failure

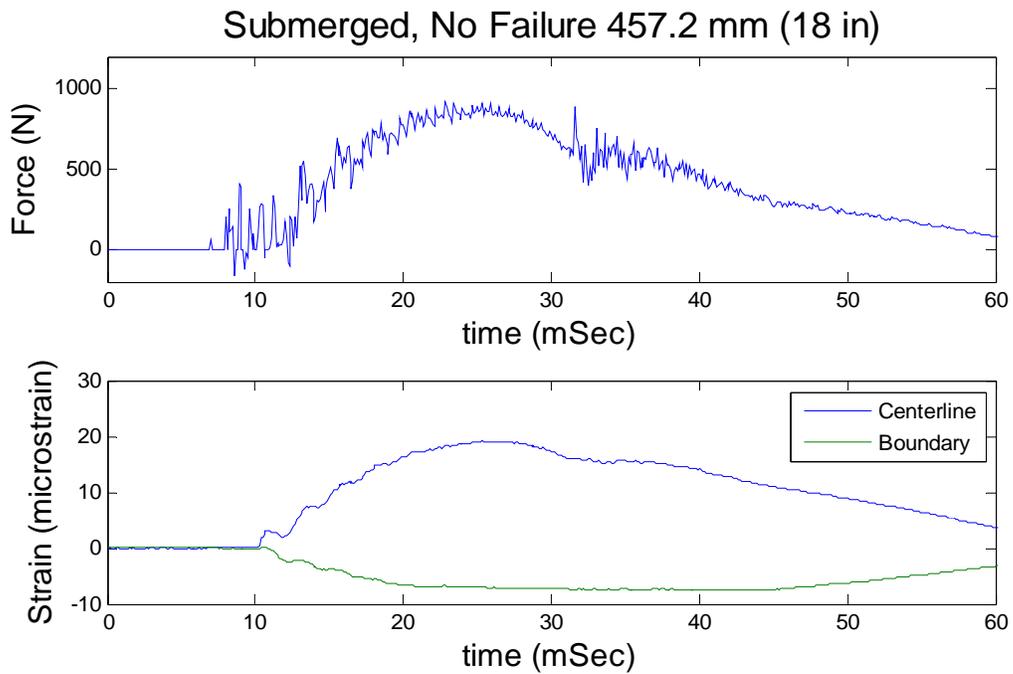
Figure 18. Submerged impact, no failure

A third batch of strain gages was glued on using conventional techniques. These gages responded much like the other set, and, in fact, no centerline gages were able to last through the entire impact sequence or even up to peak force. This set appears to have increased in strength do to a more complete cure, and all samples were much stronger than the previous test one month prior even though they were cut from the same panel (Figures 18-21).

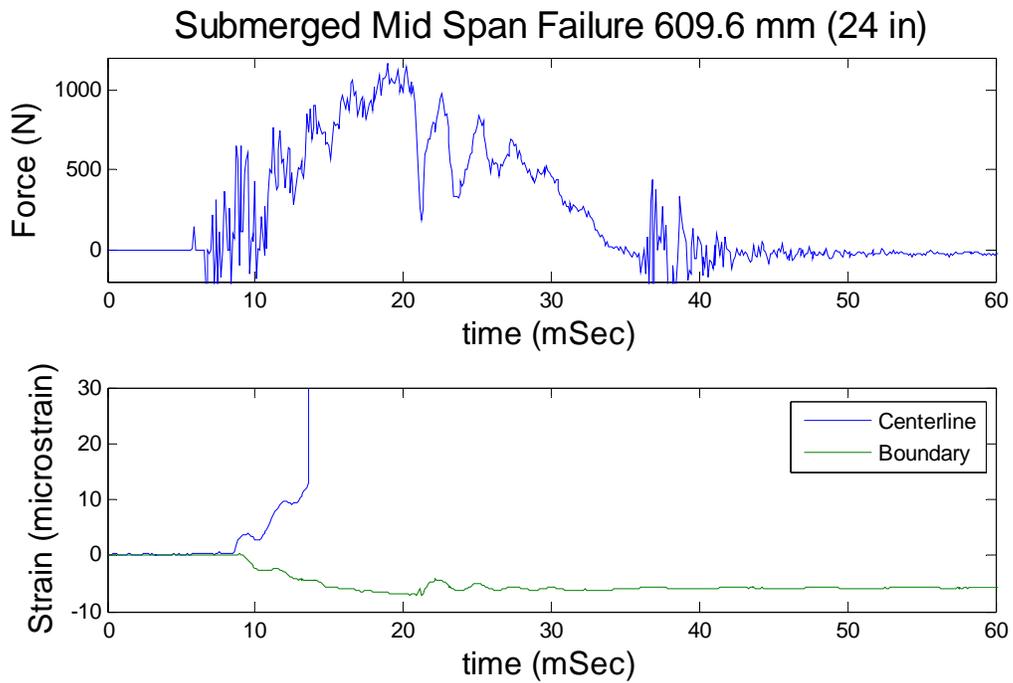
Figure 19. Submerged impact, mid-span failure

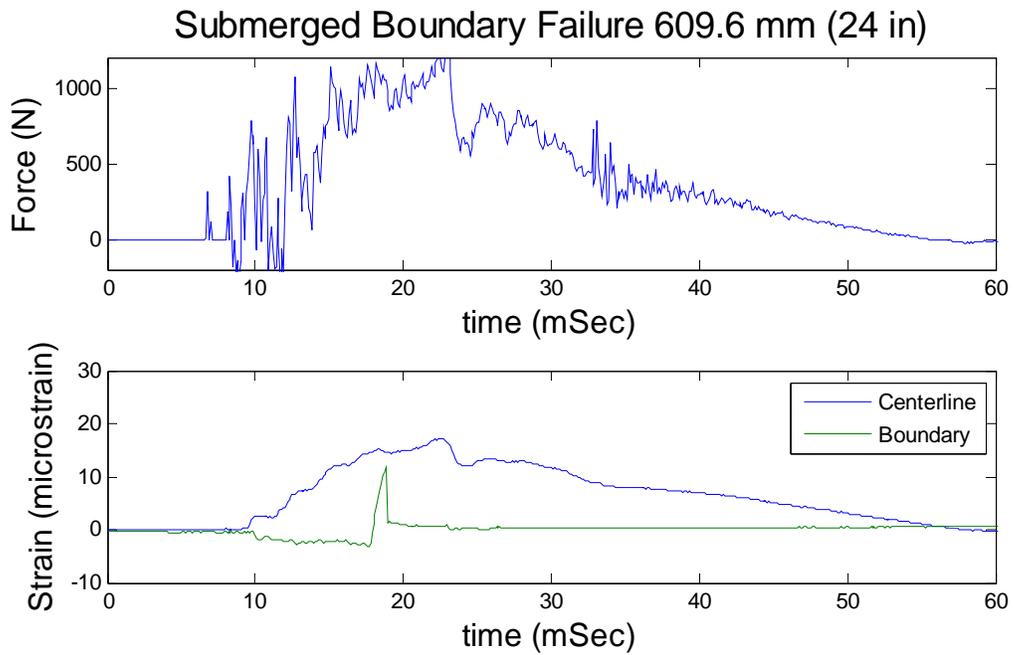
Figure 20. Submerged impact, boundary failure

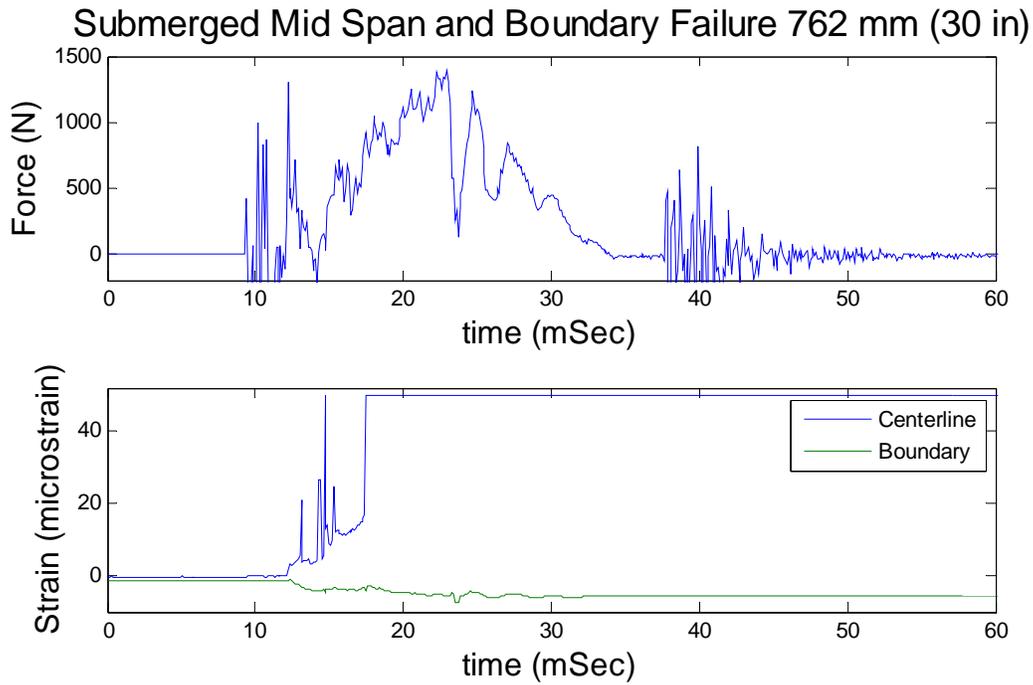
Figure 21. Submerged impact, boundary and mid-span failure

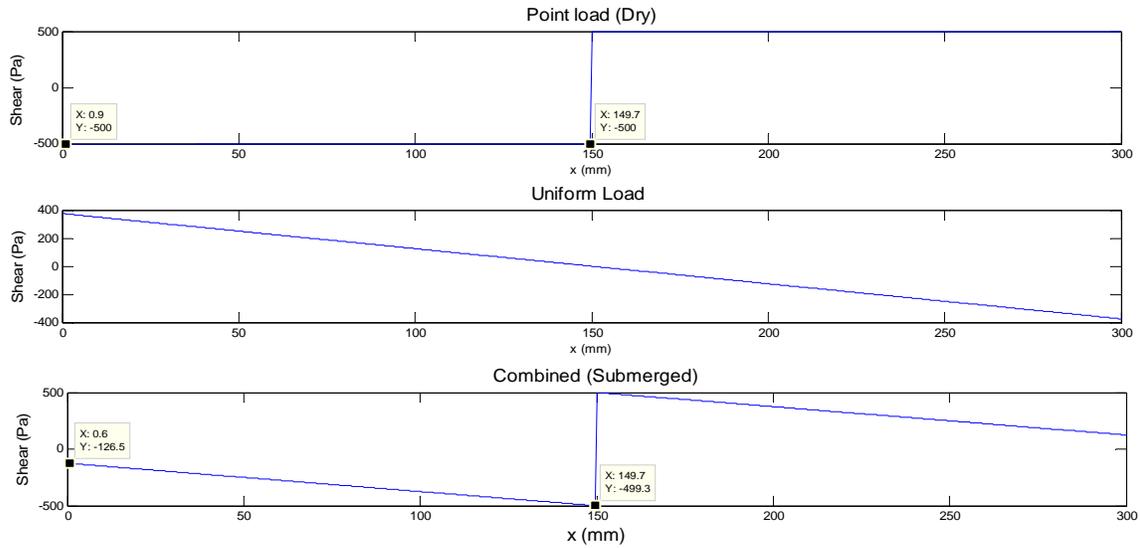
Dry impact failure mode is dominated by skin failure in compression on the bottom of the beam at either edge. Some samples also showed evidence of shear failure in the core at the same point, while submerged impact damage was dominated by failures at center span. To understand this phenomenon, it is helpful to examine the shear and bending diagrams of each situation. With a downward point load at the center representing impact force, a beam in a clamped/clamped condition has the magnitude of the shear force is constant throughout the beam and the maximum bending moment is equal at center span and each edge. Assuming an upward uniform load distribution to represent the forces from the fluid structure interaction and then using superposition to combine the two curves shows a very interesting result. The graphs in Figures 22 and 23 were generated using a point load of -1000 N as seen in testing, and an assumed uniform load of 2.5 N/m to simulate the resistance imparted by the water as the sample accelerates under impact.

In the submerged samples, the absolute value of the bending moment decreases across the span but has a more significant effect on edges. The max bending moment is no longer shared by three points but instead found solely at center span. At the same time, the amount of shear force the sample experiences at the boundaries decreases significantly. Because failures are often mixed mode, and the clamped boundary condition creates a significant stress riser, the combination of max shear force and max bending moment at the edge of the dry beam seems very logical for failure at the edges. The reduction in both shear and bending moment at the edges for submerged samples also explains why submerged samples would be more likely to experience failure at center span.

Figure 22. Shear force diagram

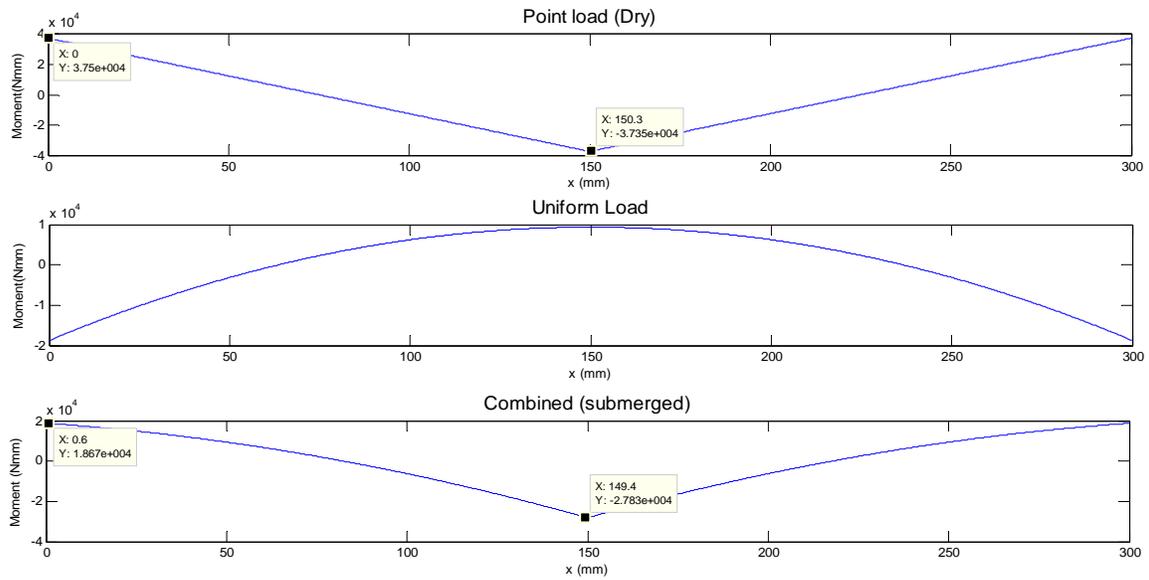
Figure 23. Bending moment diagram
