## Investigation of the accelerated corrosion of cupro-nickel piping

| Item Type | Thesis |
| Authors | Brown, Martin Richard |
| Publisher | Massachusetts Institute of Technology |

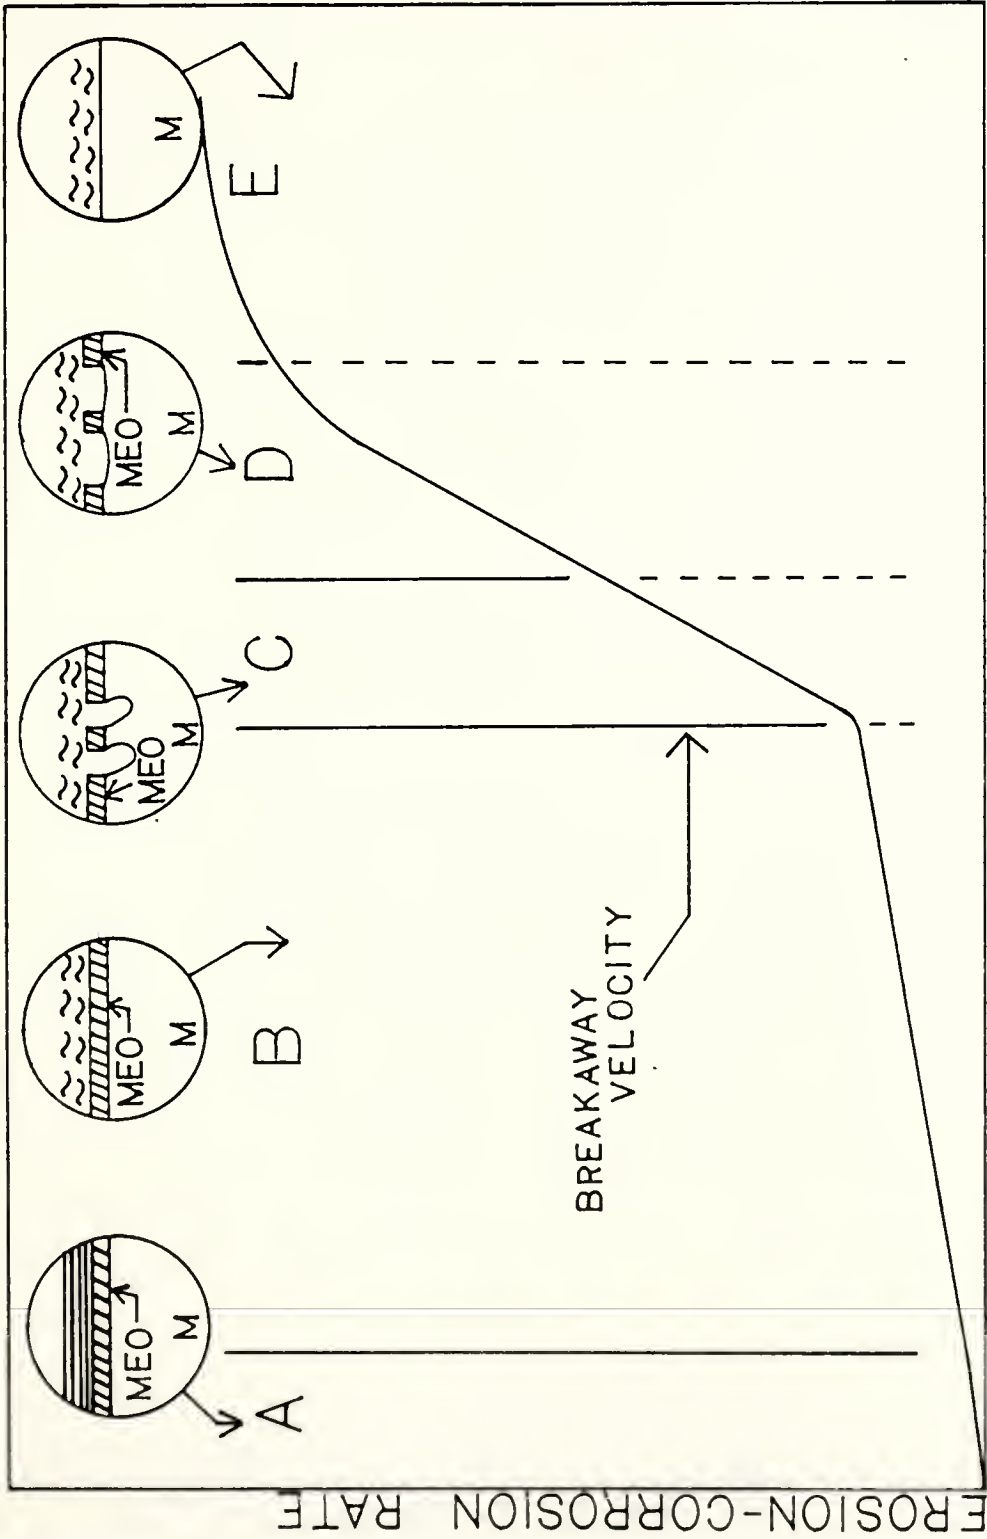
FIG. 1

VELOCITY

EROSION-CORROSION RATE

BREAKAWAY VELOCITY

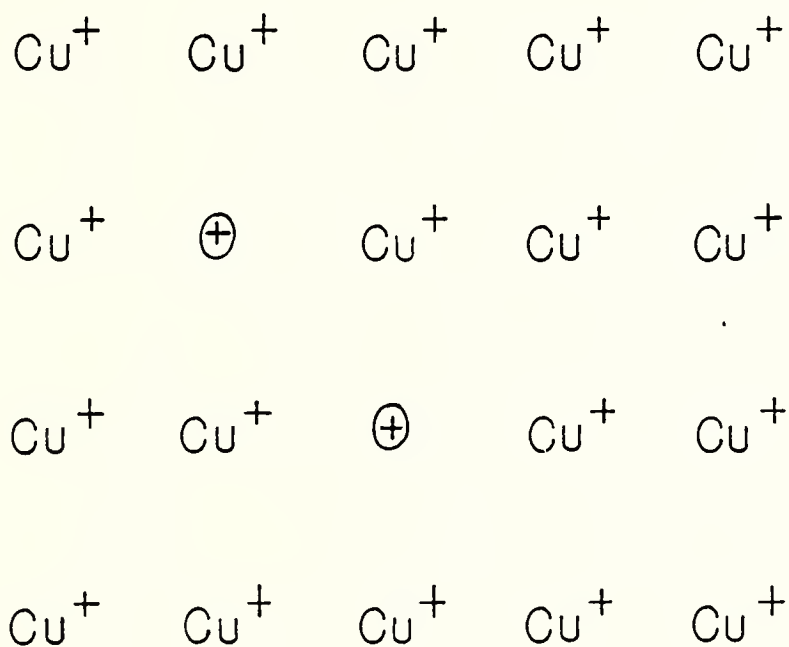
FIG. 3

DEFECTIVE CATION LATTICE OF  $\text{Cu}_2\text{O}$

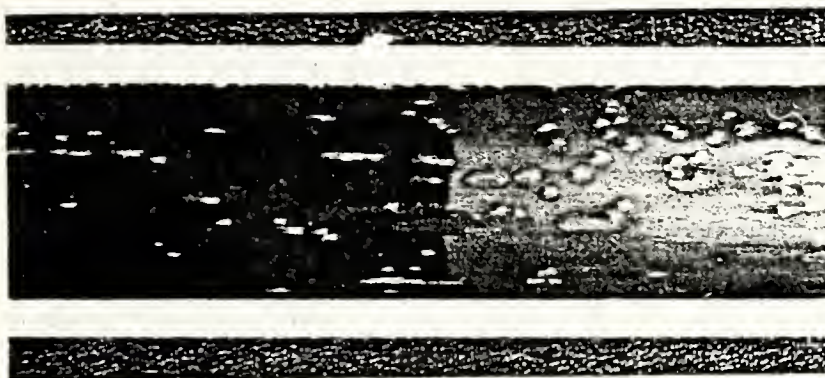
FIG. 11

SALT  
SULFIDE

The SEM was used to analyze two samples which contained the surface films of interest, specifically the following: (1) thin, dark film, (2) thick, flaky film, (3) pit corrosion product, (4) reddish film, and (5) base metal inside a pit. Sample 4 (Salt + Sulfide) and sample 6 (Salt + High Ammonia + Sulfide) were used as representative samples. Sample 4, it will be remembered, contained widely spaced pits slightly larger than sample 3 (Figures 10 and 11). Figure 17 shows a representative pit from sample 4 with the

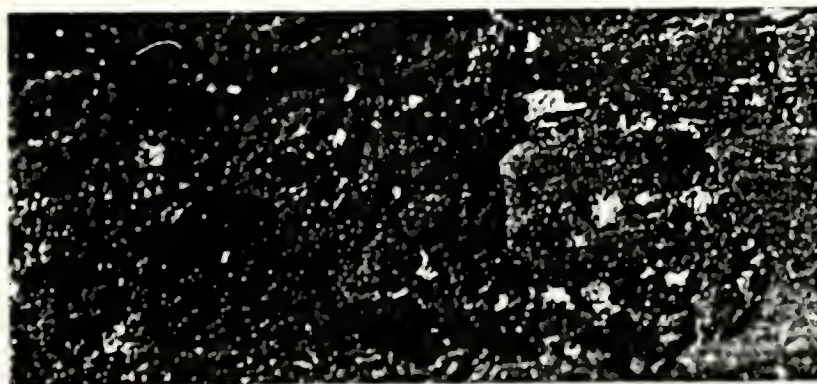
FIG. 13

SALT  
HIGH NH<sub>3</sub>  
SULFIDE

Whereas the increase in ammonia when it was the only contaminant had little effect, the same procedure in the presence of sulfide exhibited several noticeable effects. Firstly, the dark brown film, which was thin and smooth earlier, became very thick and flaky. Figure 13 shows the film and its very thick, flaky nature. When the nonadherent film was removed, there was a metallic surface underneath it, similar to the interior of a corrosion pit. Figure 14 shows the same sample with part of the flaky film removed, revealing the extensive corrosion beneath. The areas that were still intact were reddish in color, indicating the presence of the same film discussed in previous samples. Figure 15 shows the effect of the increase in ammonia in the presence of

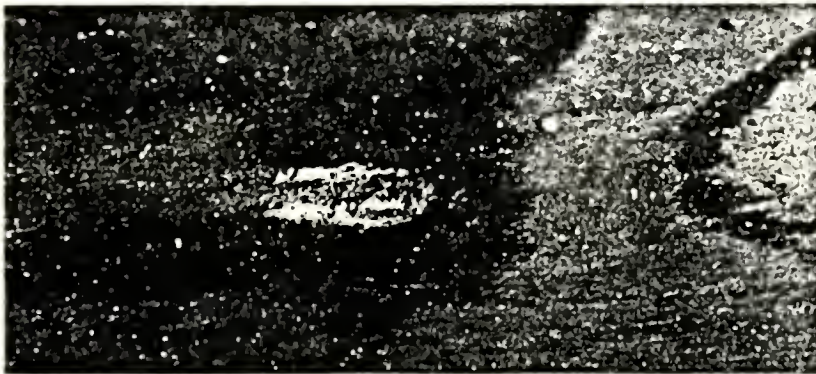
FIG. 18

SALT  
SULFIDE

thin, dark film removed but partial corrosion product still intact. Figure 18 shows the transition from the cleaned area to the area covered by the thin, dark brown film complete with a corrosion product covered pit. It should be noticed that the dark film is loose but not at all of a flake nature. Figure 19 is a high magnification of the thin, dark brown film showing its loose, powder-like characteristics. An Energy Dispersive X-Ray Analysis (EDAX) scan of the thin, dark film is reproduced in Figure 20, showing the sulfur to be a primary constituent, and otherwise dominated by copper. Primarily for completeness, Figures 21 and 22 are included showing respectively: (1) a corrosion pit with corrosion product partially intact, and (2) a high magnification of a three-way junction of the inner pit base metal, the corrosion product, and the corrosion film. Sample 6 (Figures 14 and 15) did not reveal any significant differences from sample 4, other than the thickness of the dark corrosion film discussed earlier. Figure 23 is a slightly higher magnification than before showing the flakiness of the film and its nonadherence. The actual identification of the surface films, to the extent of the capability of EDAX, was as follows:

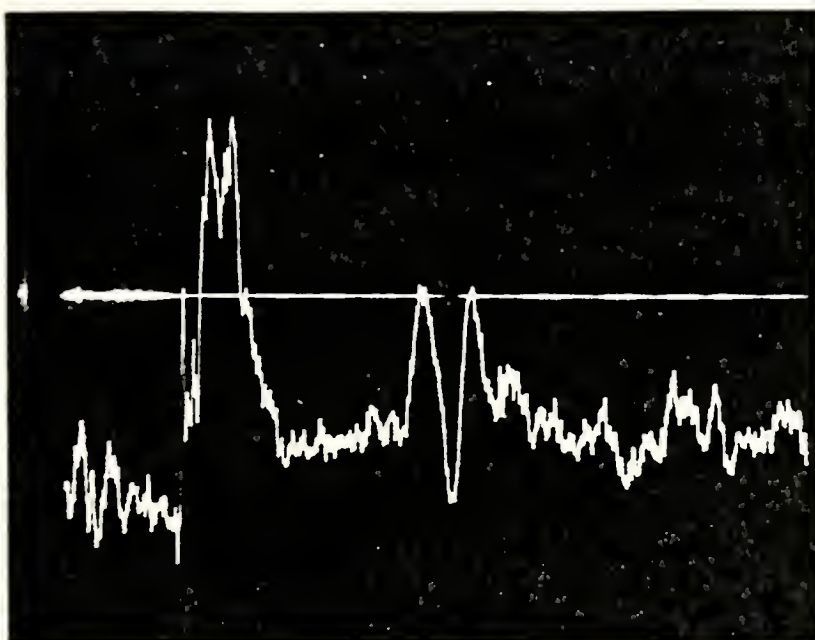
FIG. 25

COPPER

cation of surface films could not be made, specifically the identification of  $\text{CuCl}$  and  $\text{Cu}_2\text{O}$ . One very interesting aspect of the SAM analysis was the line scans performed. Figure 25 is a line scan of sulfur passing from the dark film area to the lighter reddish area, with points above and below the line signifying the presence or absence, respectively, of sulfur. Figures 25 and 26 were line scans of a corrosion pit, with the corrosion product removed, showing the relative presence of copper and nickel. This was the same result given by EDAX analysis. No other specific conclusions could be reached as a result of SAM analysis.

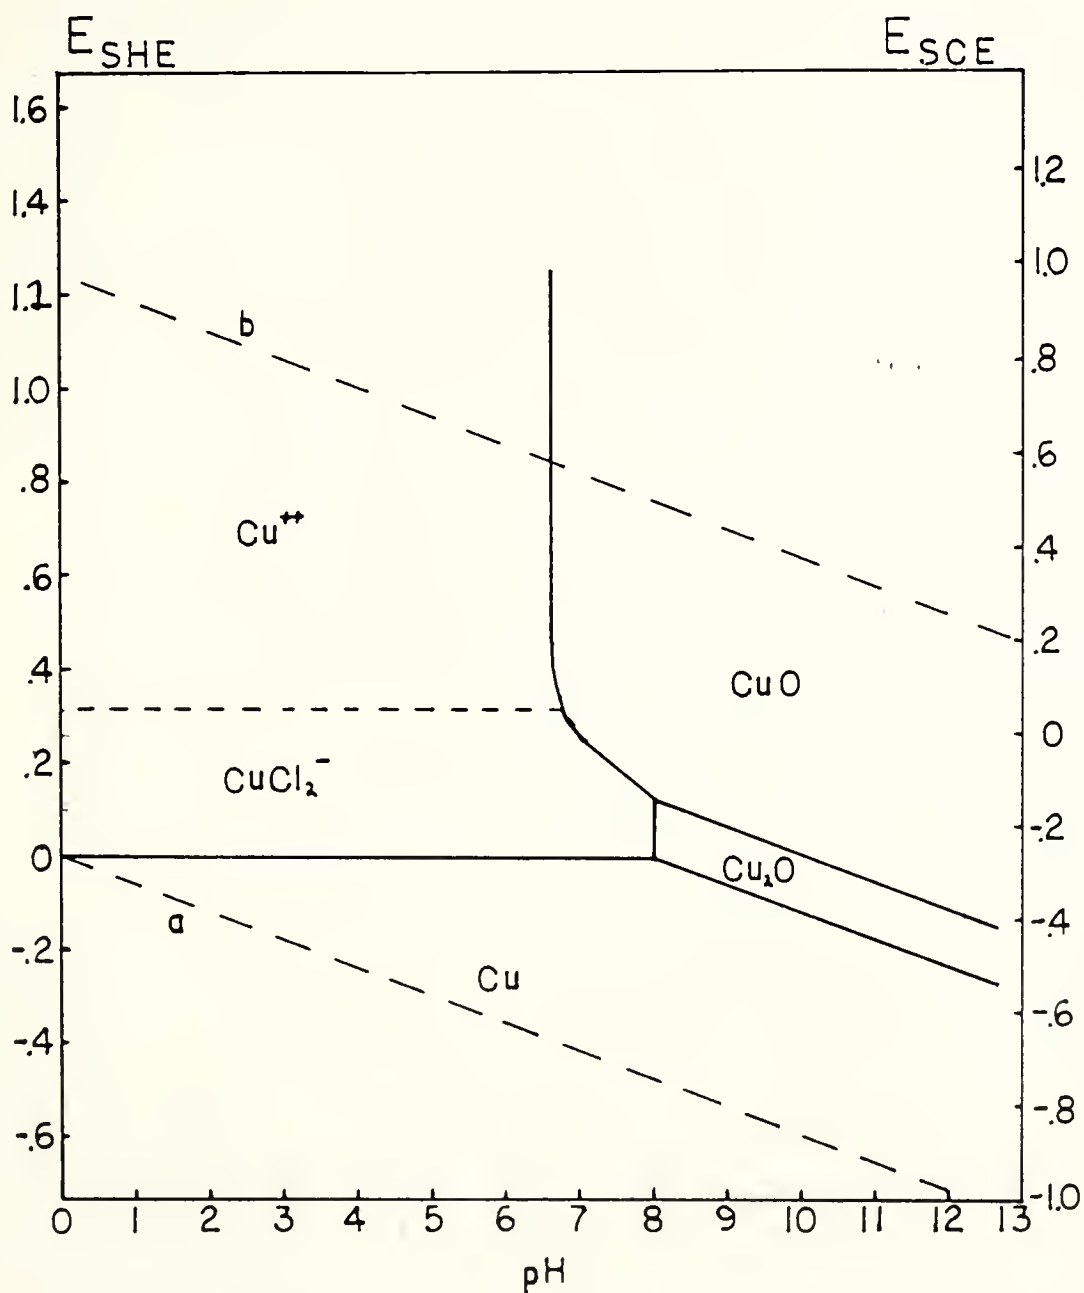
FIG.27

POURBAIX DIAGRAM FOR PURE COPPER

| | | <u>Page</u> |
|---|--|---|
| Figure 27 | Pourbaix Diagram for Pure Copper | 81 |

The analysis of corrosion product films was not really conclusive in the area of oxides. The experimental observations discussed in chapter 2 identified the oxide film as  $\text{Cu}_2\text{O}$  which is reddish in color (32) and appears to be the reddish film discussed earlier. Reference to Figure 27, which is a Pourbaix diagram for pure copper, indicates that at the stagnant solution potential of  $-210\text{mv}$  (SCE) and a pH above 8.0, the corrosion film should indeed be  $\text{Cu}_2\text{O}$ , as expected. At the same pH but a potential of  $-130\text{mv}$  (SCE), however, the corrosion film should be  $\text{CuO}$ . Figure 28 is an experimental Pourbaix diagram for alloy 715 (34) and at the same pH and potentials as above, the alloy is again in the same region. These observations and the results discussed

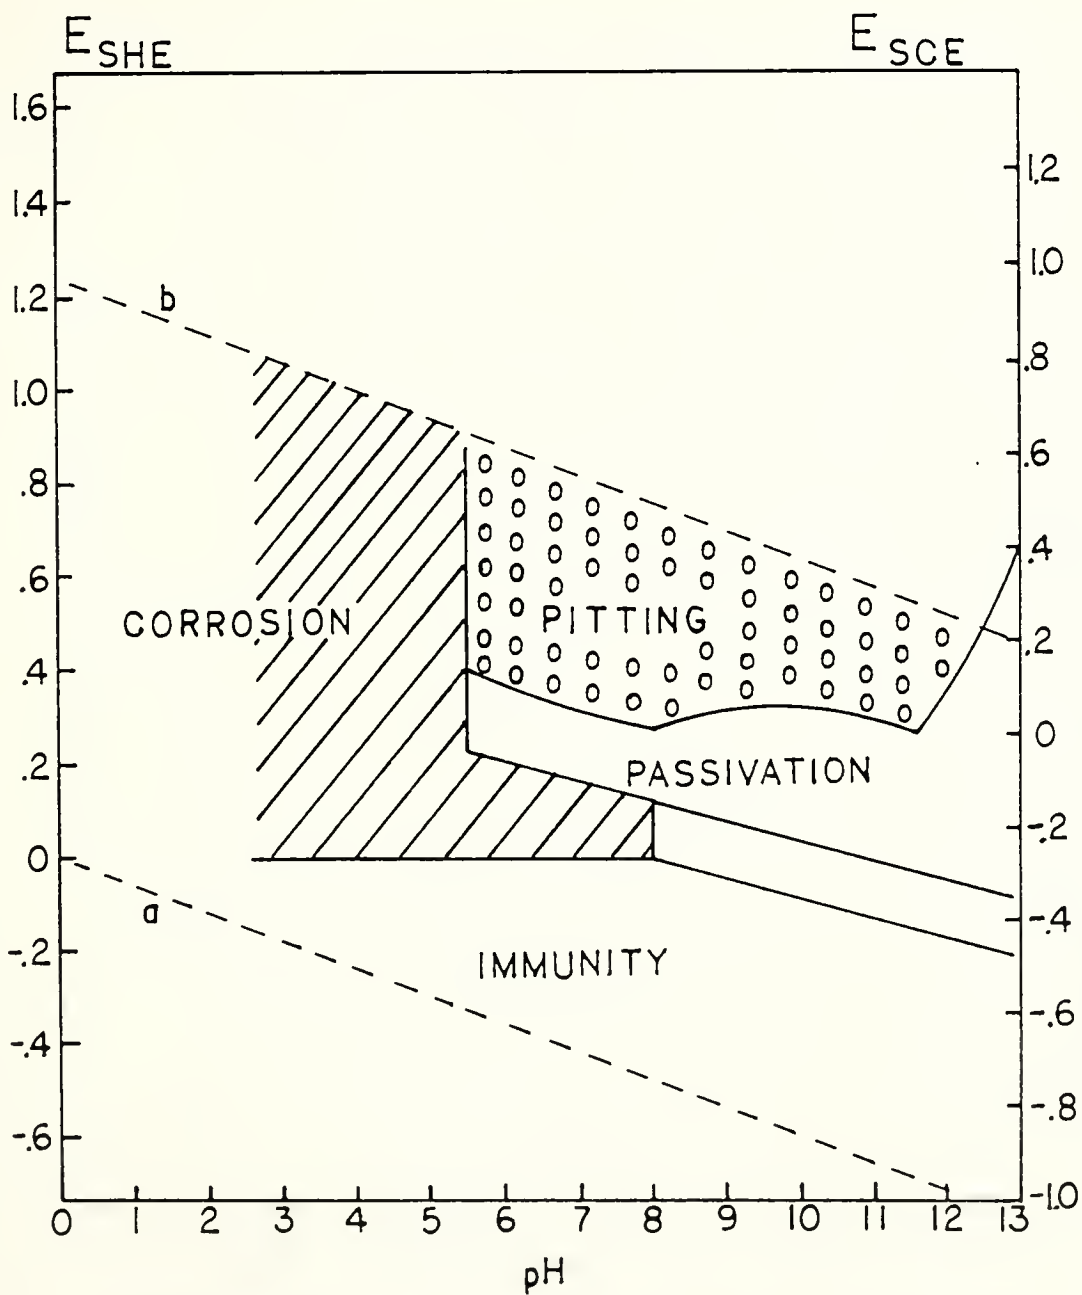
FIG. 28

EXPERIMENTAL POTENTIAL-PH DIAGRAM  
FOR 70-30 CUPRONICKEL
