THESIS

**STRUCTURAL HEALTH MONITORING: NUMERICAL DAMAGE
PREDICTOR FOR COMPOSITE STRUCTURES**

Daniel L. Lannamann

March 2001

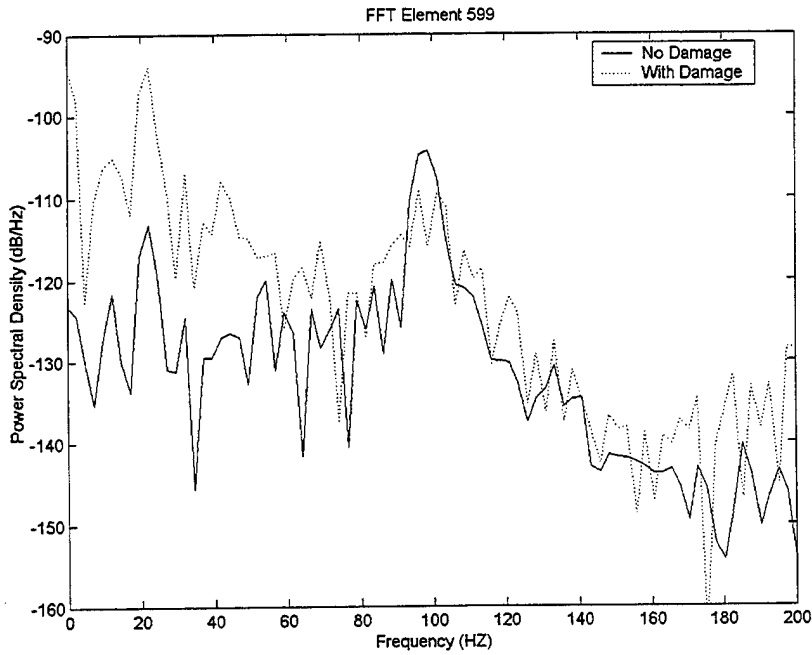
Figure 13a. Strain at Left Crack Tip, Element 599 (0.240 – 0.242m), Case 1 (0.24 – 0.25m)

Figure 13b. PSD at Left Crack Tip, Element 599 (0.240 – 0.242m), Case 1 (0.24 – 0.25m)

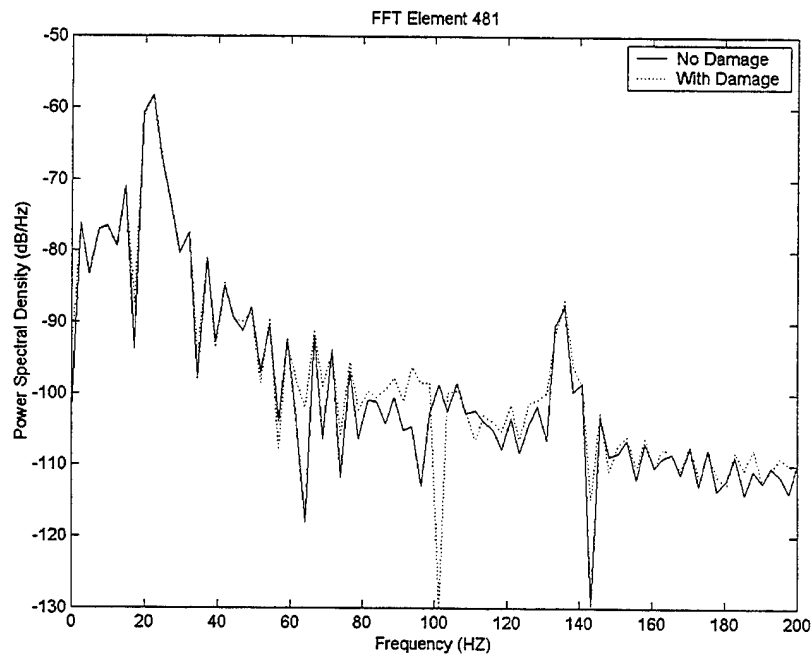
Figure 19a. Strain Inside the Crack, Element 481 (0.004 – 0.006m), Case 2 (0.0 – 0.01m)

Figure 19b. PSD Inside the Crack, Element 481 (0.004 – 0.006m), Case 2 (0.0 – 0.01m)

Element location	Damage Location	Figure/Element	Detection Probability
0.000 – 0.002m	0.00 – 0.01m	18/479	Low
0.004 – 0.006m	0.00 – 0.01m	19/481	Low
0.010 – 0.012m	0.00 – 0.01m	20/484	Low
0.034 – 0.036m	0.00 – 0.01m	21/496	High
0.042 – 0.044m	0.00 – 0.01m	22/500	High
