DEVELOPMENT OF A TEST PROCEDURE FOR
SPUTTERED GOLD AS A SOLID FILM GEAR
TOOTH LUBRICANT

DEVELOPMENT OF A TEST PROCEDURE
FOR SPUTTERED GOLD AS A SOLID
FILM GEAR TOOTH LUBRICANT

MASTER OF SCIENCE IN MECHANICAL ENGINEERING

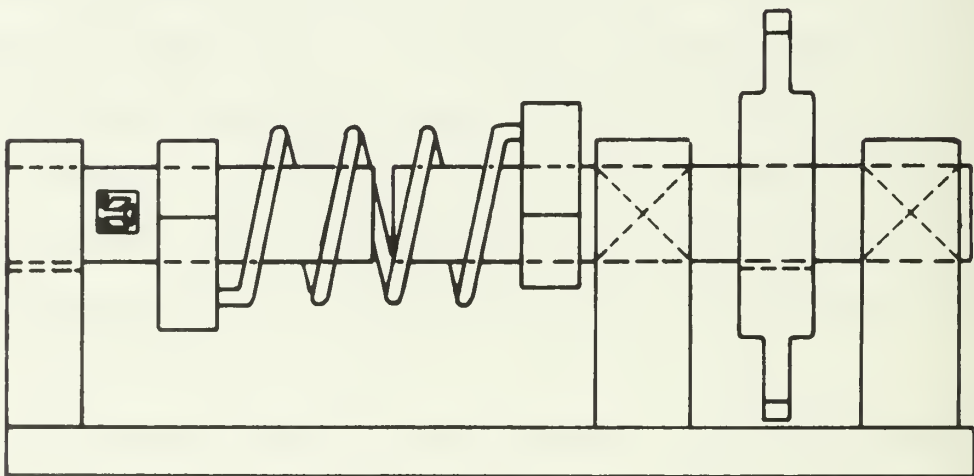
FIGURE 9 - PROPOSED TEST GEAR SHAFT AND SUPPORT BEARING ARRANGEMENT FOR ONE-MOTOR OPERATION

conditions would seem to depend on having the motion of the driving pinion for each current pulse the same for both motors. Because of slight variations of the motor mechanisms, the planetary transmissions, and the external gear teeth, the angle of rotation may not be the same for each pulse. Various configurations of contact between mating teeth have been observed. On several occasions, it appeared that there was contact on both sides of the same tooth. On one occasion the teeth were observed to rotate without any contact between them, indicating that the other gear was carrying the entire load. In light of these circumstances it may be deemed advisable to re-design the Lubricant Tester for one motor operation. The use of bearings placed close to the test gear and two shafts coupled by the spring may sufficiently reduce the effects of bending caused by the gear separating forces. Figure 9 illustrates one possible configuration where the helical spring transmits torque between two shafts.

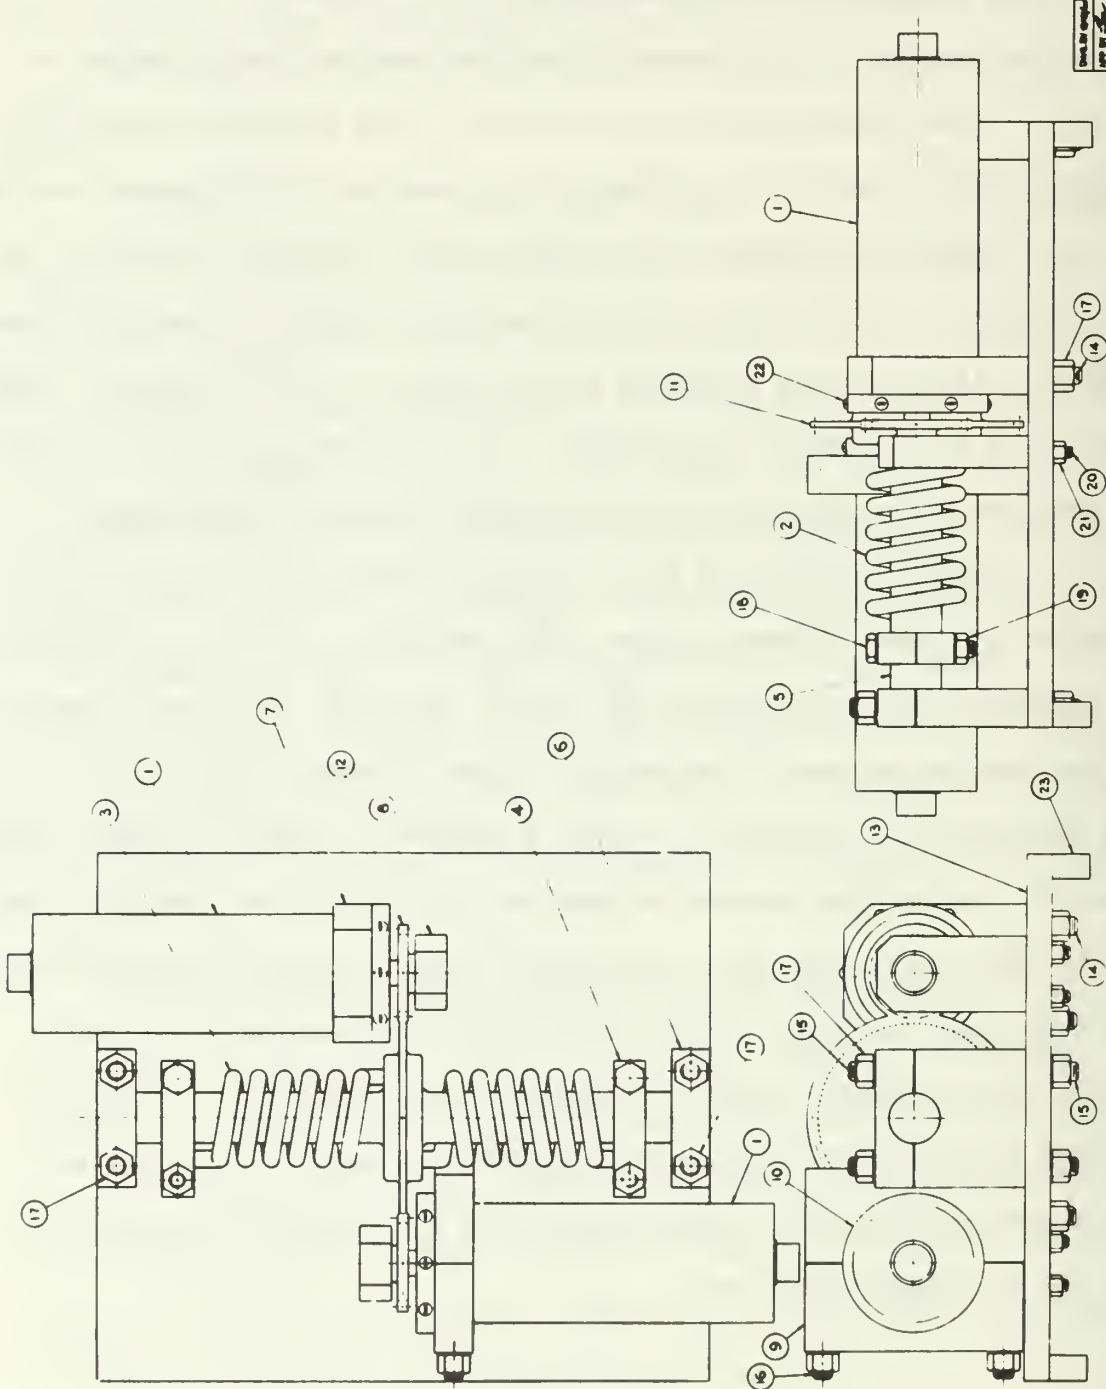
FIGURE 10 - ASSEMBLY DRAWING OF LUBRICANT TESTER

NO.	DESCRIPTION	QTY
23	STAND LEGS	4
22	1/2" DIA. X 1/4" THK. STEEL WASHERS	16
21	1/2" DIA. X 1/4" THK. STEEL WASHERS	4
20	1/2" DIA. X 1/4" THK. STEEL STUDS	4
19	1/2" DIA. X 1/4" THK. STEEL WASHERS	4
18	1/2" DIA. X 1/4" THK. STEEL WASHERS	4
17	1/2" DIA. X 1/4" THK. STEEL WASHERS	4
16	1/2" DIA. X 1/4" THK. STEEL WASHERS	4
15	1/2" DIA. X 1/4" THK. STEEL WASHERS	4
14	1/2" DIA. X 1/4" THK. STEEL STUDS	4
13	MOUNTING PLATE	1
12	DRIVING PITCH	1
11	TEST GEAR	1
10	MOTOR COLLAR	1
9	MOTOR SUPPORT, ADJUSTABLE	1
8	DRIVE GEAR SUPPORT	2
7	MOTOR SUPPORT	1
6	SHAFT PILLOW BLOCKS	2
5	TEST GEAR SHAFT	1
4	SPRING RETAINER	2
3	SPRING - LH	1
2	SPRING - RH	1
1	STEP MOTOR	1
NO.	DESCRIPTION	QTY

1. Select the desired direction of gear rotation. For a given contact force, determine the number of teeth on the test gear that will pass through contact while winding the springs to achieve this selected load. For future reference this number of teeth shall be called "off-set."
