NPS-EC-07-001

An Initial Examination of the Occupancy and Use of the Wireless-Radio Bands

by Wilbur R. Vincent, Richard W. Adler, Andrew A. Parker, and George F. Munsch

September 2006

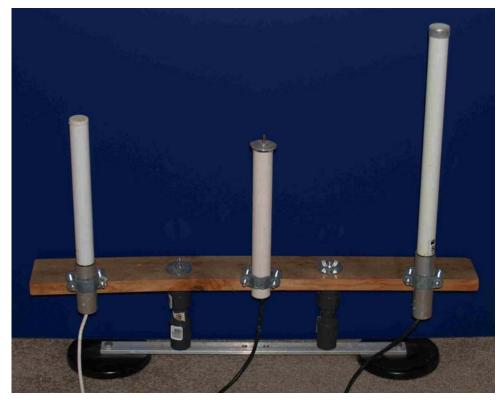
Figure 2 Antennas used for the 915-MHz, 2.4-GHz, and 5.8-GHz Bands

Figure 2 provides a photograph of the three antennas most often used to examine the occupancy and use of the 5.8-GHz, 2.45-GHz and the 915-MHz bands. The antenna for the 2.45-GHz band is on the left, the antenna for the 5.8-GHz band is in the center, and the antenna for the 915-MHz band is on the right. All antennas are placed on a magnetic mount for quick and easy use with a vehicle. Short lengths of low-loss coaxial cable were used for the antenna-to-filter connection.

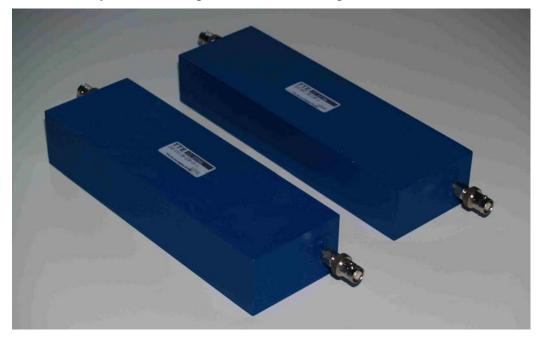
Figure 3 Bandpass Filters for the 915-MHz and 1.2-GHz Bands

Figure 3 shows a photograph of the filters used for the 915-MHz and the 2.4-GHz bands. These filters are physically large to provide linear operation for the maximum total signal power imposed onto their input terminals. Many additional high-dynamic range filters were accumulated over the years for other portions of the radio spectrum.

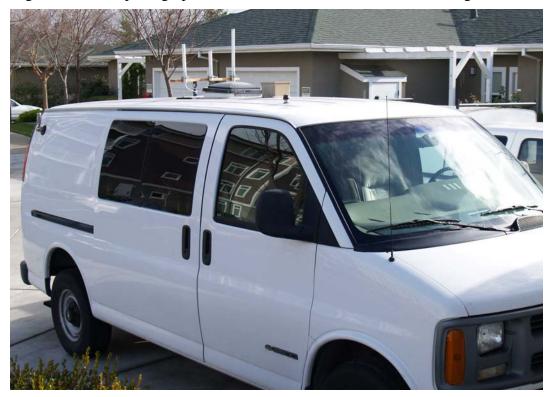
Figure 1 Photograph of Instrumentation Van

Figure 1 shows a photograph of the van and the roof-mounted receiving antennas.

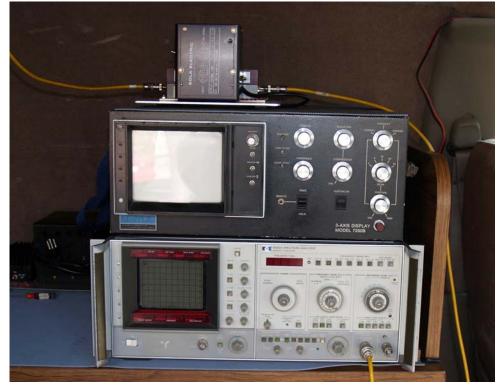
Figure 2 Instrumentation for the 2.4-GHz Band

A high dynamic range preamplifier with a gain of 24 dB is at the top of the instrumentation. The time-history display is the large black instrument, and a Hewlett-Packard Model 8565 Spectrum Analyzer is on the bottom of the suite. A laptop computer and a digital oscilloscope camera is located to the immediate left of the above instruments. Similar instrumentation suites are installed further to the left of the 2.4-GHz suite when simultaneous multi-band operation is desired.

Figure 2 shows the 2.4-GHz instrumentation mounted on a work table in the van. Standard instruments are strapped to the table to prevent movement and for safety during travel.

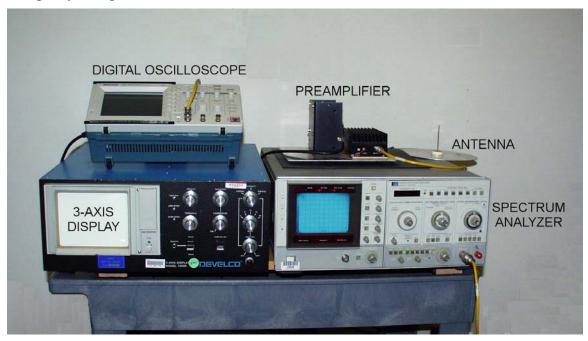
Figure 2 Photograph of Instrumentation

Figure 2 is a photograph of the instrumentation used to collect the band use and occupancy data provided in this memorandum.

The instrumentation was located and operated in a small storage area at the rear of the classroom. One wall separated the instrumentation from the classroom. The nearest laptop was about 15 feet from the instrumentation while the furthest was about 30 feet from the instrumentation. The Access Point was about 25 feet from the instrumentation. This arrangement allowed data to be collected without interruption to normal class activities. Examples of data collected are provided to illustrate conditions encountered by the classroom network.

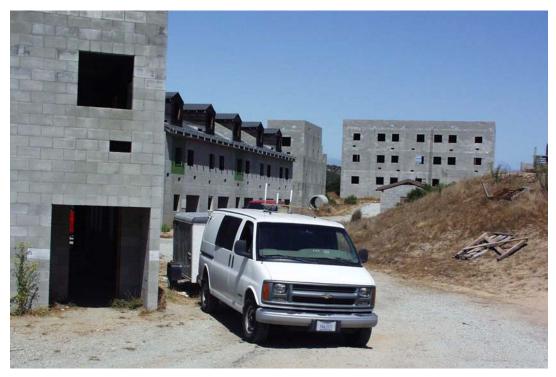
Figure 1 Photograph of Instrumentation Van at the MOUT Site

Figure 1 shows a photograph of the instrumentation van at the MOUT site.

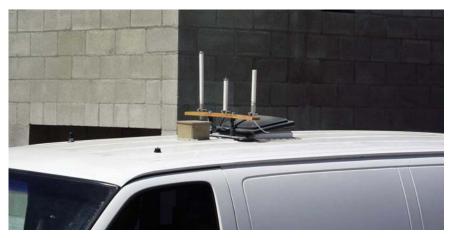
Figure 3 Photograph of Antennas on the Instrumentation Van

Antennas for each band of interest were installed in the roof of the van. Figure 3 shows the three antennas used for these measurements. Short coaxial cables ran from each antenna through the roof vent and to instrumentation preamplifiers located directly below the roof vent.

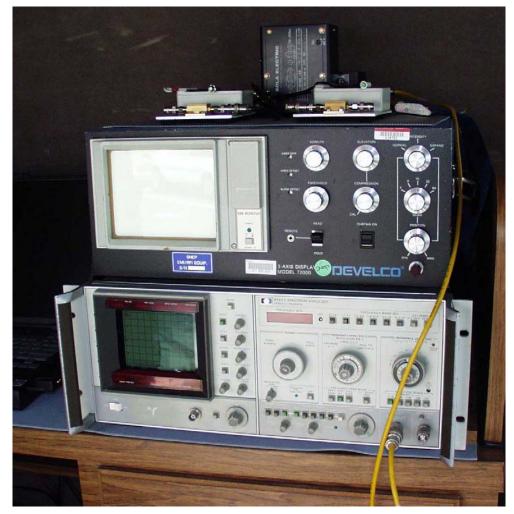
Figure 4 Instrumentation for the UHF and Microwave Bands

Two sets of instrumentation were installed in the van. One set covered the band from 0.1 MHz up to 1250 MHz. The second set covered the frequency range of 10 MHz up to 14 GHz. Figure 4 is a photograph of the 10-MHz to 14-GHz instrumentation. A Hewlett Packard Model 3565A Spectrum Analyzer is on the bottom of the photograph, the time-history display in the middle of the photograph, and preamplifiers are on the top of the time-history display.

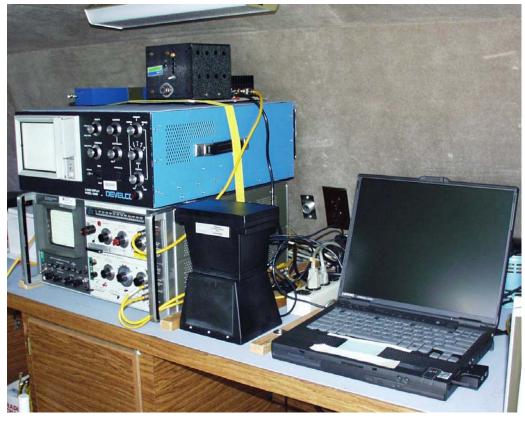
Figure 5 Instrumentation for the 0.1- to 1250-MHz Band

Figure 5 is a photograph of the instrumentation used to cover the 0.1 to 1250 MHz frequency range. A Hewlett Packard Model 141 Spectrum Analyzer is shown on the lower left part of the photograph. The time-history display used to observe signals in the 0.1- to 1250-MHz band is above the spectrum analyzer, and its preamplifier and a filter are located on top of the display.

The oscilloscope camera used to photograph examples of data is in the center of the photograph, and the laptop computer used to store and process data is at the right edge of the photograph. These two items were shared with the first instrumentation suite to minimize equipment and allow all data files to be stored on one computer.

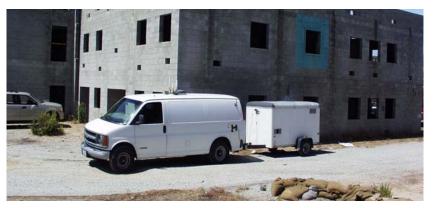
Figure 1 Photograph of Instrumentation Van

A Naval Postgraduate School instrumentation van was equipped with radio spectrum measurement equipment and was used for this effort. Figure 1 shows a photograph of the instrumentation van and its diesel generator trailer at a field measurement location. The van could be rapidly moved from location to location, and it could be operated while in motion.

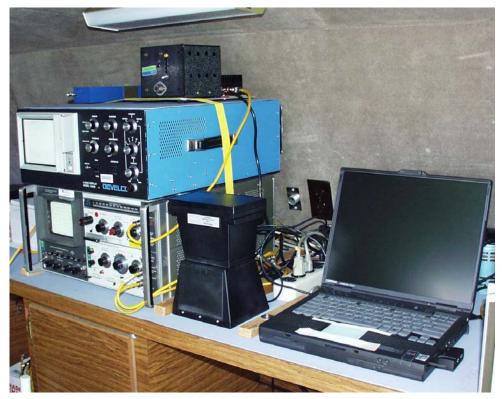
Figure 4 Instrumentation for the 0.1 to 1250 MHz Band

Figure 4 is a photograph of the instrumentation used to cover the 0.1 to 1250 MHz frequency range as well as the digital oscilloscope camera used to photograph data and the laptop computer used to store data files. A Hewlett Packard Model 141 Spectrum Analyzer is shown on the lower left part of the photograph. The time-history display used to observe signals in the 0.1 to 1250 MHz band is above the spectrum analyzer, and its preamplifier and a filter are located on top of the display.

The oscilloscope camera and the laptop computer shown in Figure 4 were shared with the first instrumentation suite to minimize equipment and allow all files to be stored on one computer.
