## Type 1 hot corrosion furnace testing and evaluation.

# NAVAL POSTGRADUATE SCHOOL

Type 1 Hot Corrosion Furnace Testing  
and Evaluation

October 1982

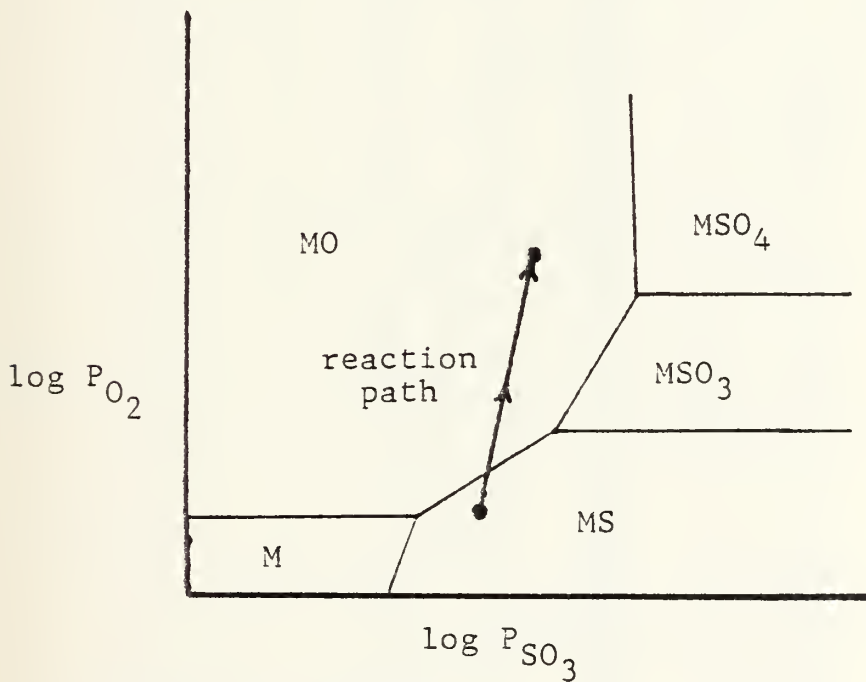
(a) Type 1 hot corrosion reactions

(b) Stability Diagram

Figure 4. Schematic diagram to illustrate type 1 hot corrosion

The type 1 hot corrosion degradation morphology is shown schematically in Figure 4. Due to the molten salt film and the partial pressure gradients of  $O_2$  and  $SO_3$ , the low partial pressure of  $O_2$  at the molten salt/protective oxide interface causes the following reactions to occur:

Gas composition encompasses two variables, partial pressures of  $O_2$  and  $SO_3$ , which are critical to both the type of attack and the rate of attack. As can be seen from the stability diagram of Figure 4, the partial pressure gradients across the molten salt layer determine the degradation mechanism. Although type 1 and type 2 hot corrosion are identified by temperature range, it is possible to have type 2 hot corrosion at higher temperatures if sufficient  $SO_3$  partial pressure is present. Efforts to accelerate type 1 hot corrosion by increasing  $SO_3$  partial pressure is limited by this fact. The  $SO_3$  partial pressure is also inversely related to temperature such that for a given  $SO_2$  input rate, the  $SO_3$  partial pressure can be increased by decreasing the temperature.
